KIYOTA LAB.

[Challenge of Geo-disaster Mitigation]

Geo-disaster Mitigation Engineering

Earthquake-induced Geo-disaster

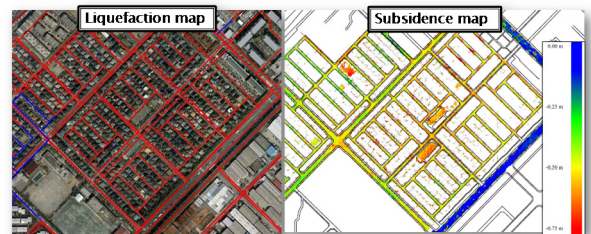
Ground subsidence map after liquefaction by Tohoku EQ

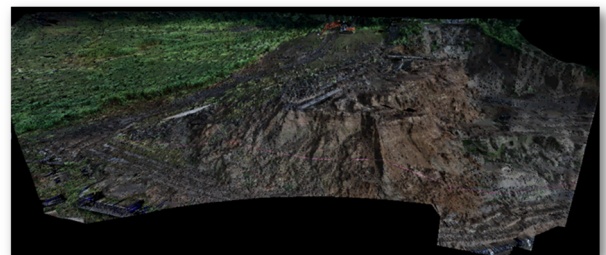
Breached dam body was LiDAR surveyed for its entire 3D image

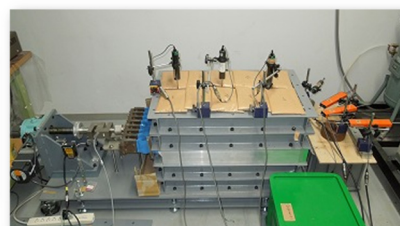
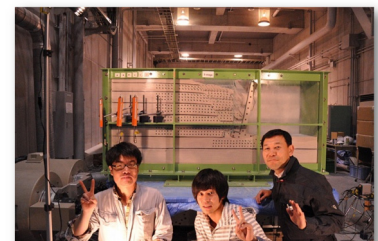
Pull-out test and shaking table model test on newly developed Geo-cell reinforced retaining wall
