KAWAGUCHI LAB.

[Safety Assessment of Ceilings and Spatial Structure Systems]

Safety of Large Roof Buildings

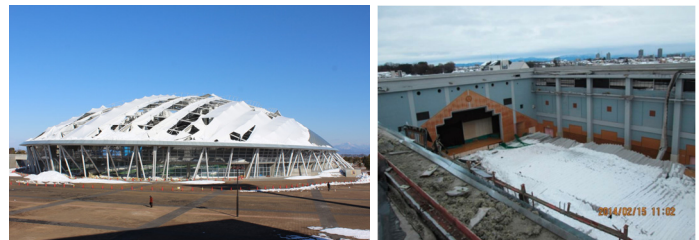
Roof collapse due to the heavy snowfall on Feb. 14, 2014

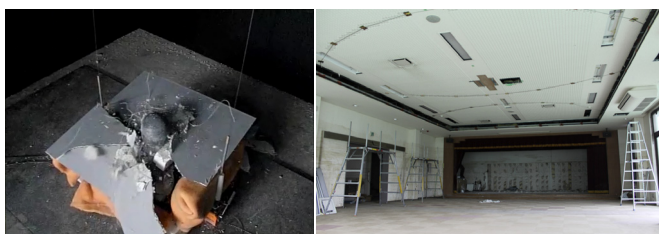
Safety assessment of ceilings by dropping experiments
