# KAWAGUCHI LAB.

## Safety of Large Roof Buildings

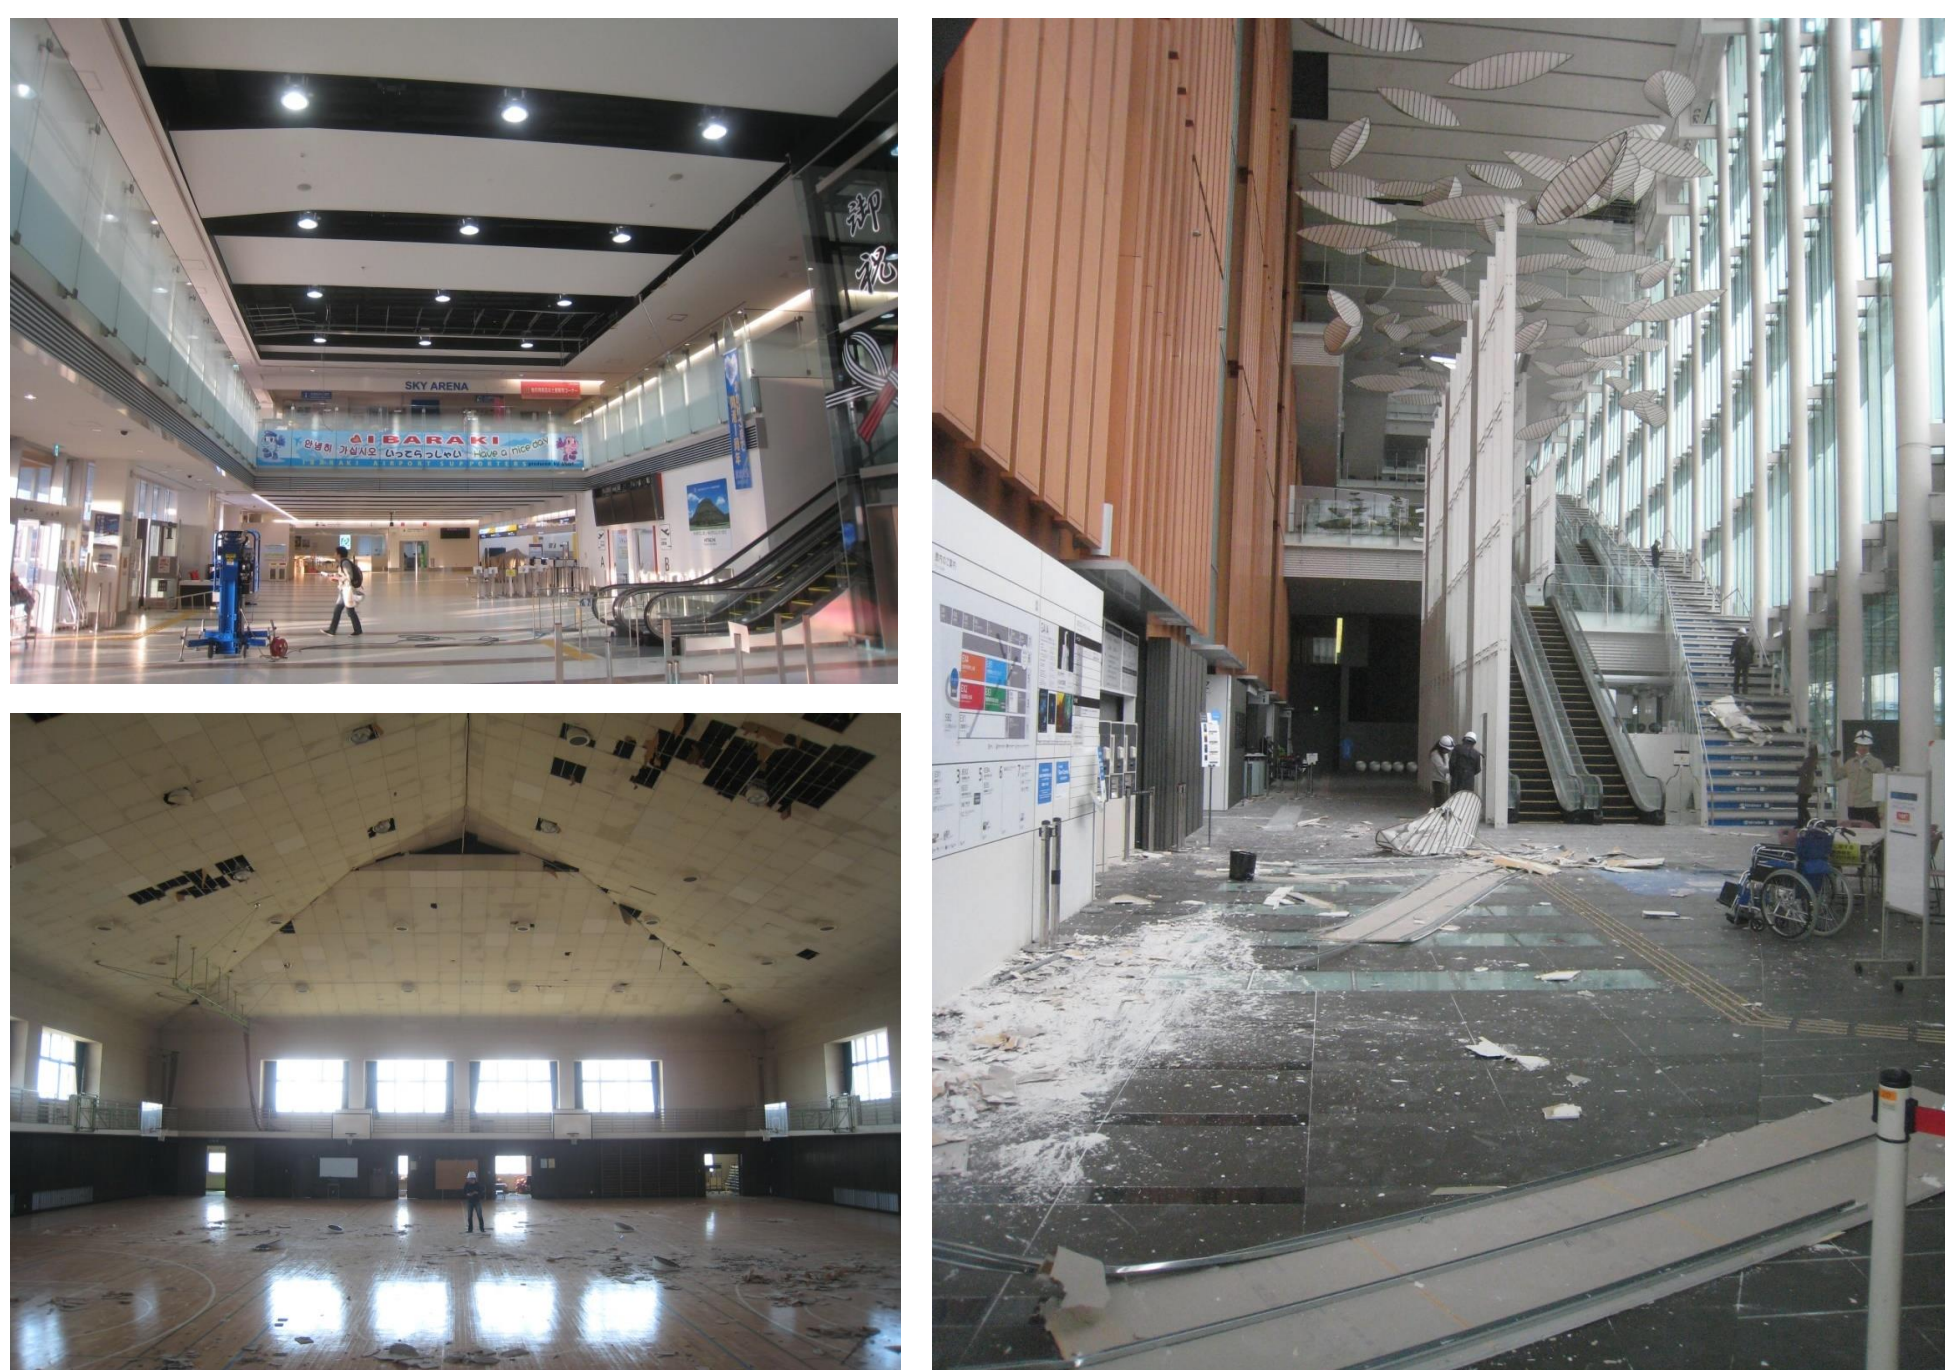
Failure of ceiling systems during the East Japan Earthquake

During the main and after shocks of the East Japan Earthquake on March 11, 2011, failures of non-structural components had occurred in many large roof buildings. Harming people due to the falling of ceiling panels had occurred as well. We have been investigating the safety of large roof buildings and developing the method to prevent the falling of ceilings.

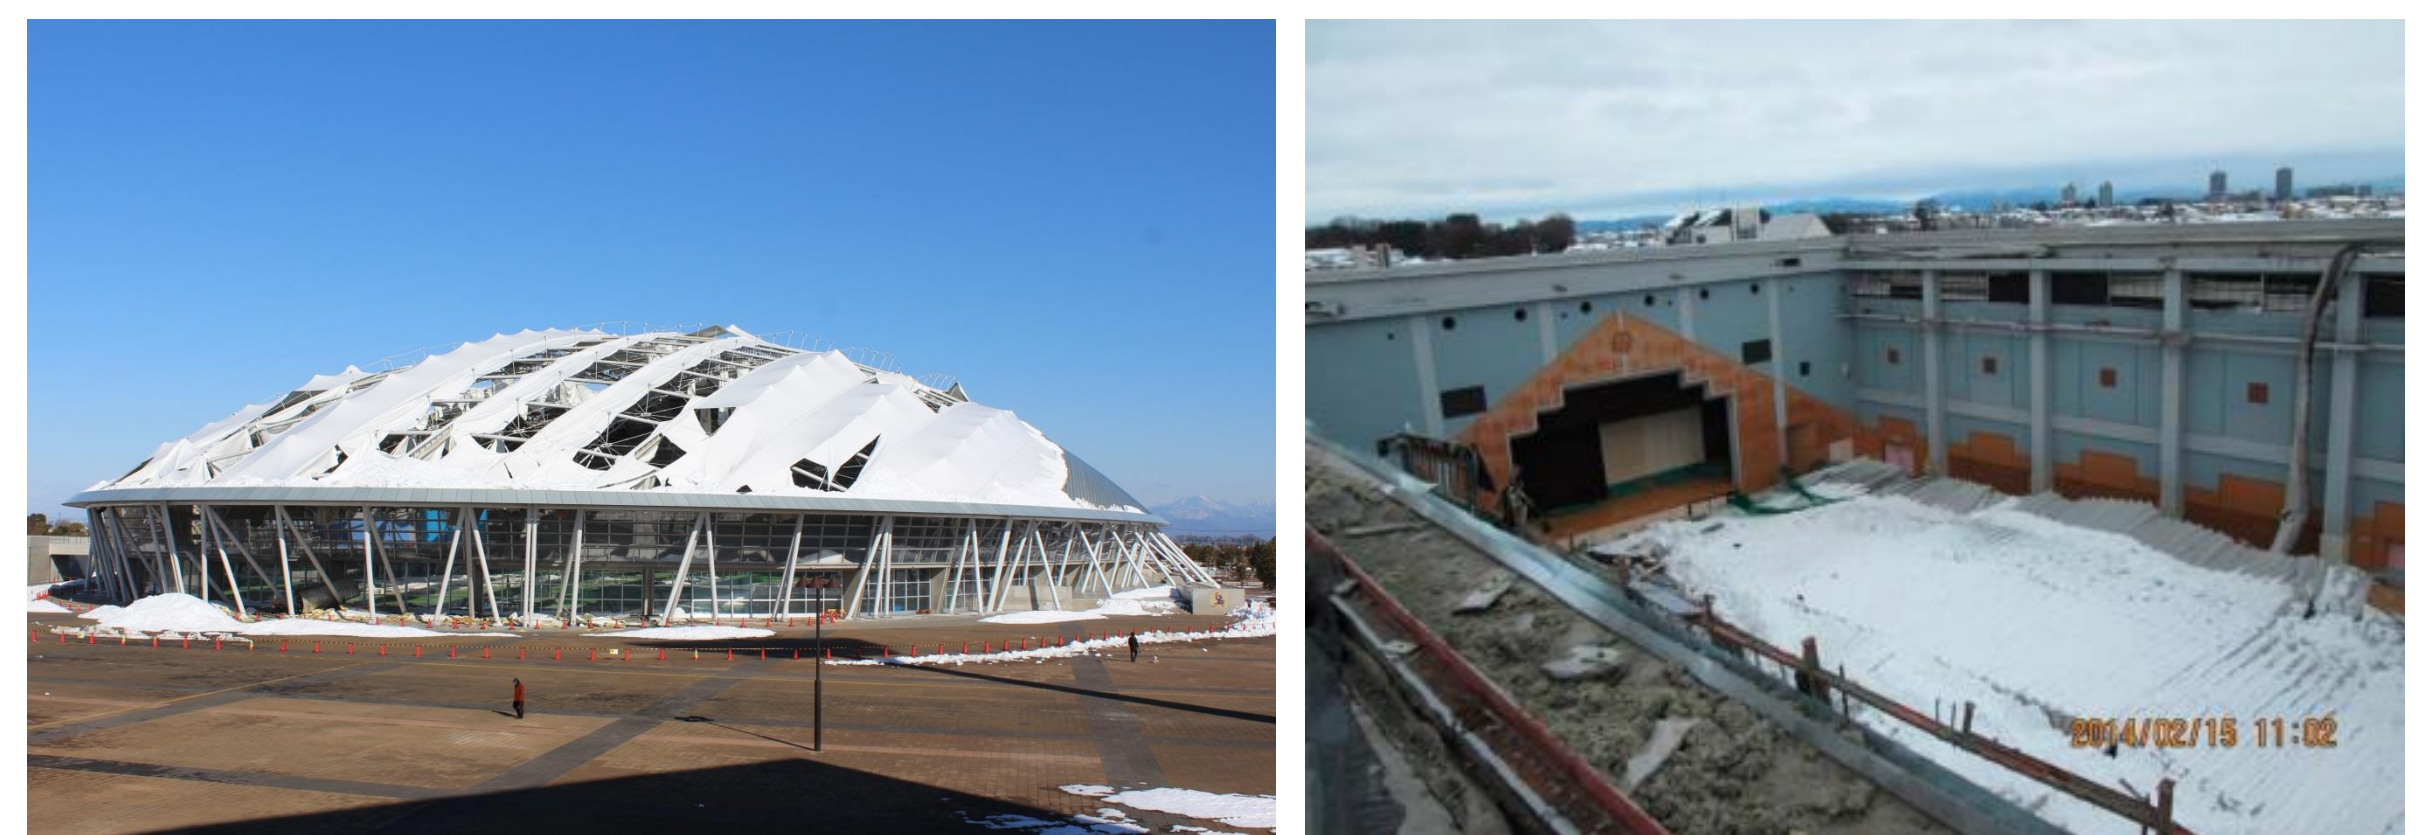
Roof collapse due to the heavy snowfall on Feb. 14, 2014

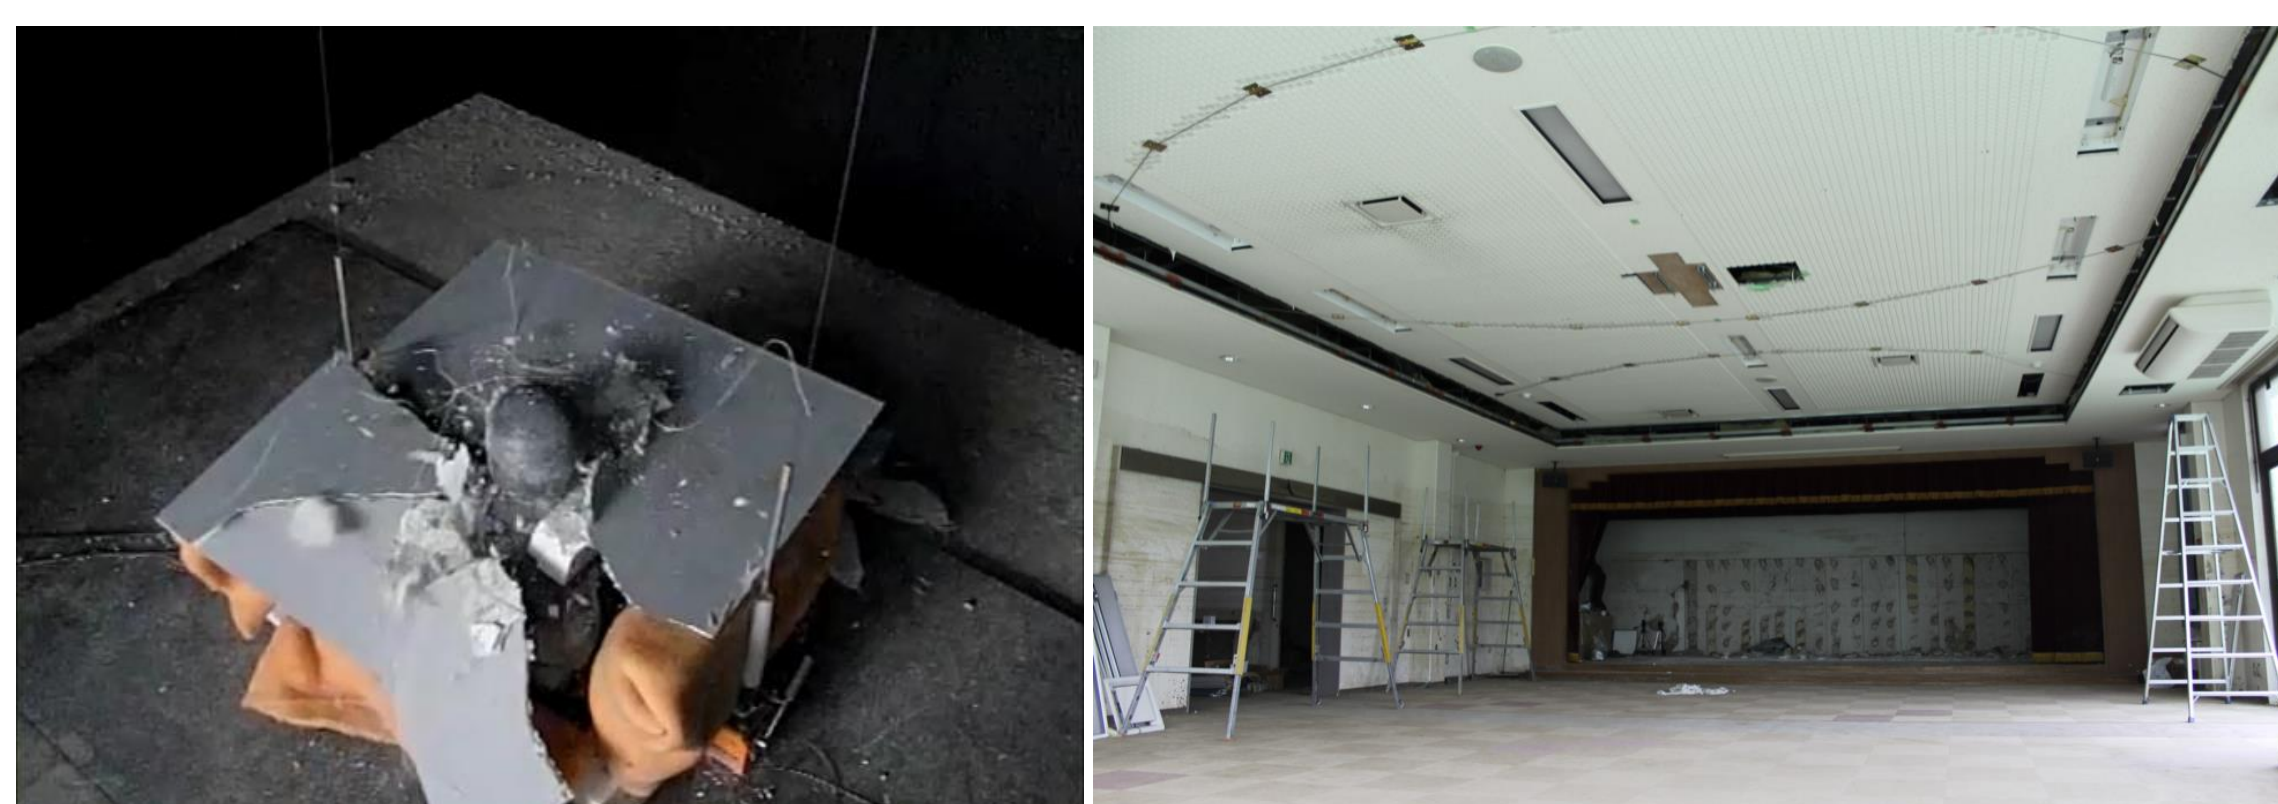
Safety assessment of ceilings by dropping experiments

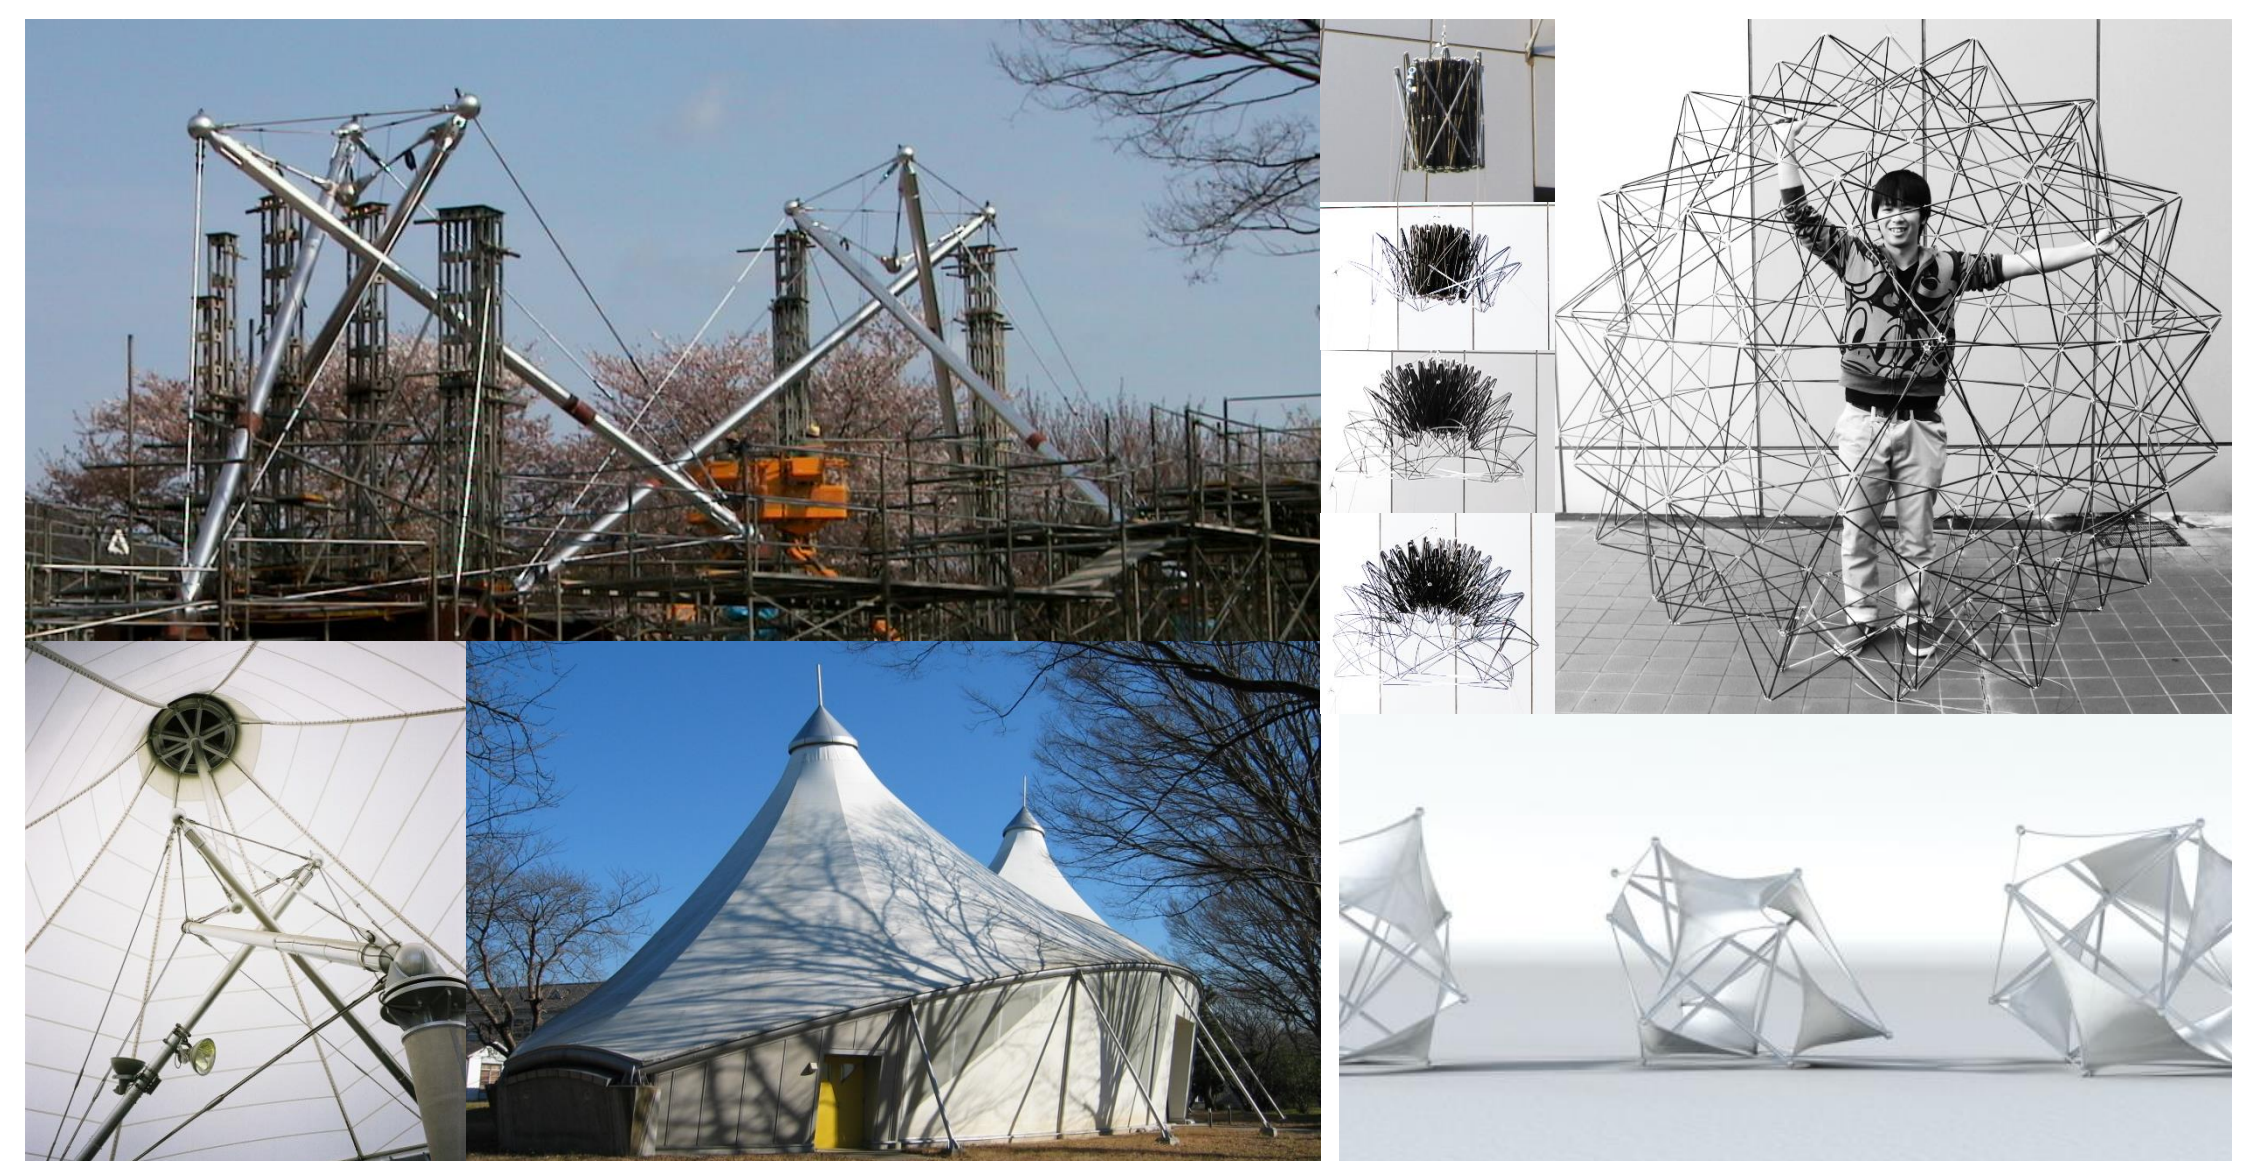
Ceiling reinforcement using cable
