KIYOTA LAB.

[Challenge of Geo-disaster Mitigation]

Geo-disaster Mitigation Engineering

Earthquake-induced Geo-disaster

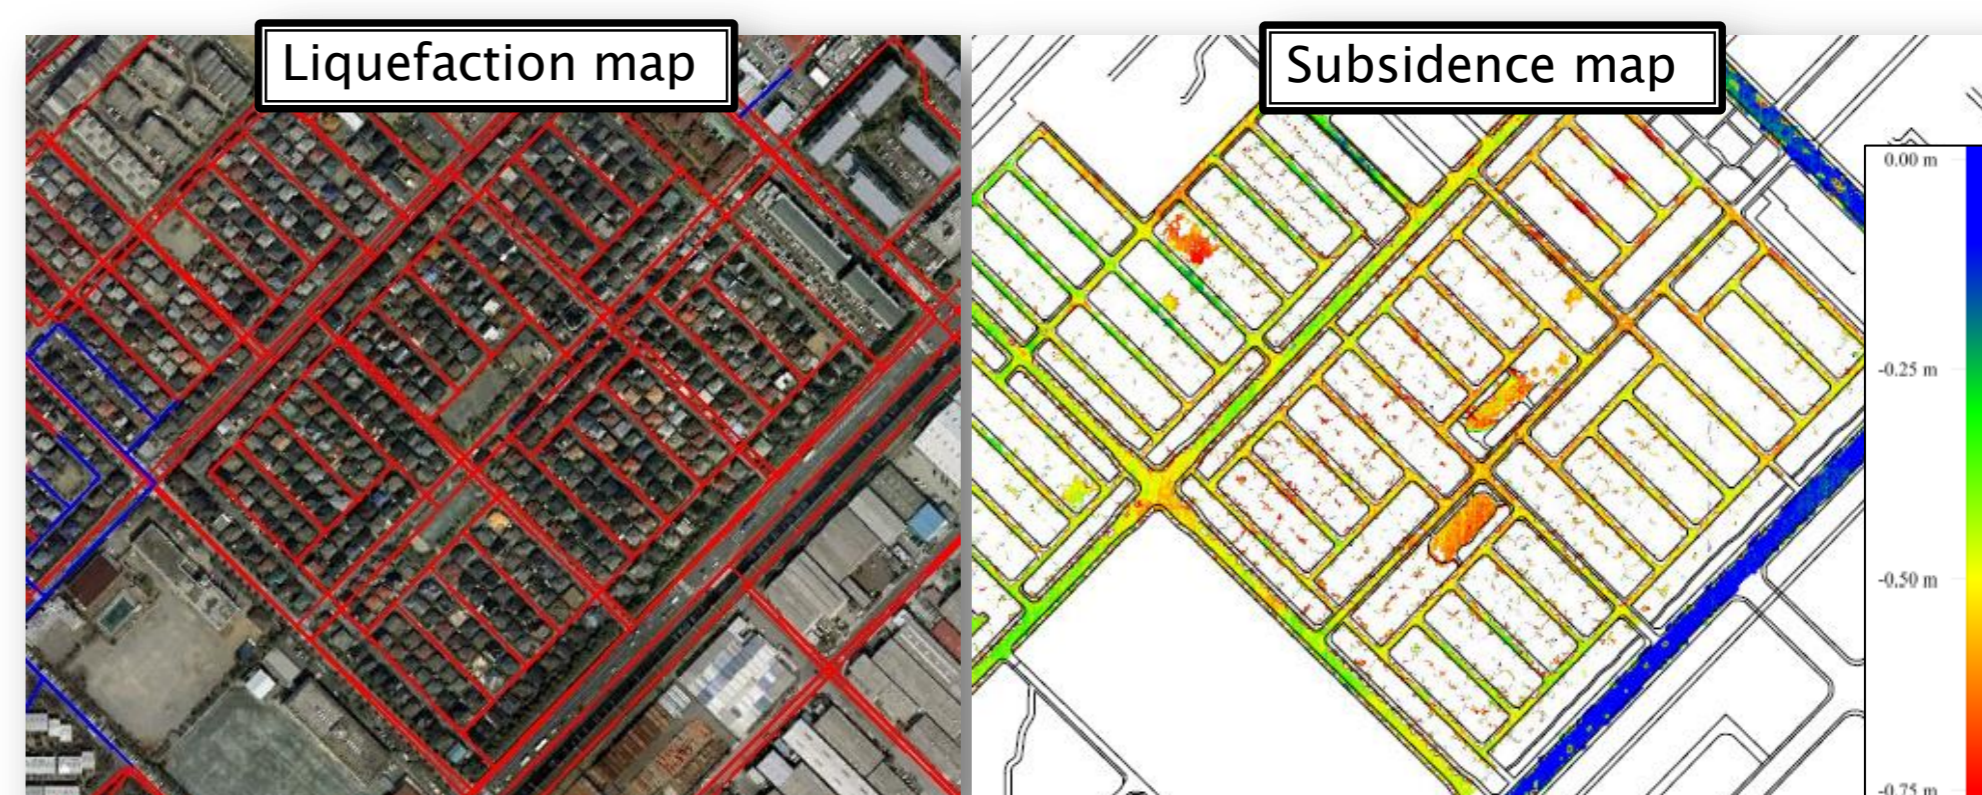
Ground subsidence map after liquefaction by Tohoku EQ

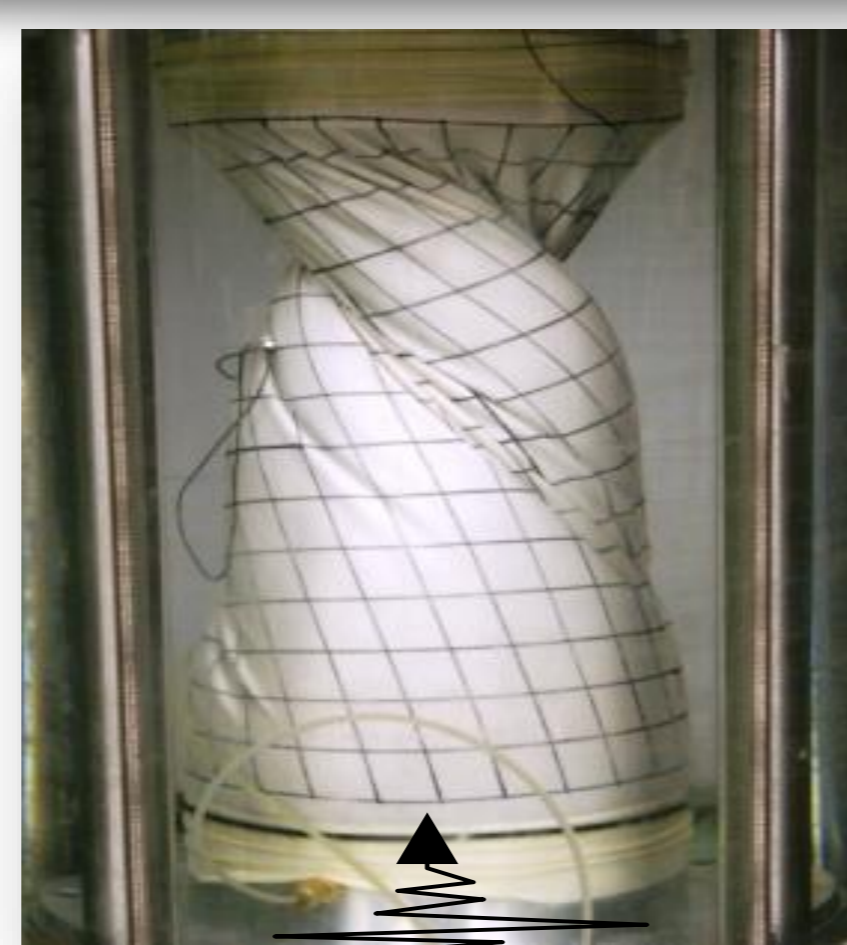
Field investigation and laboratory test on liquefaction problem

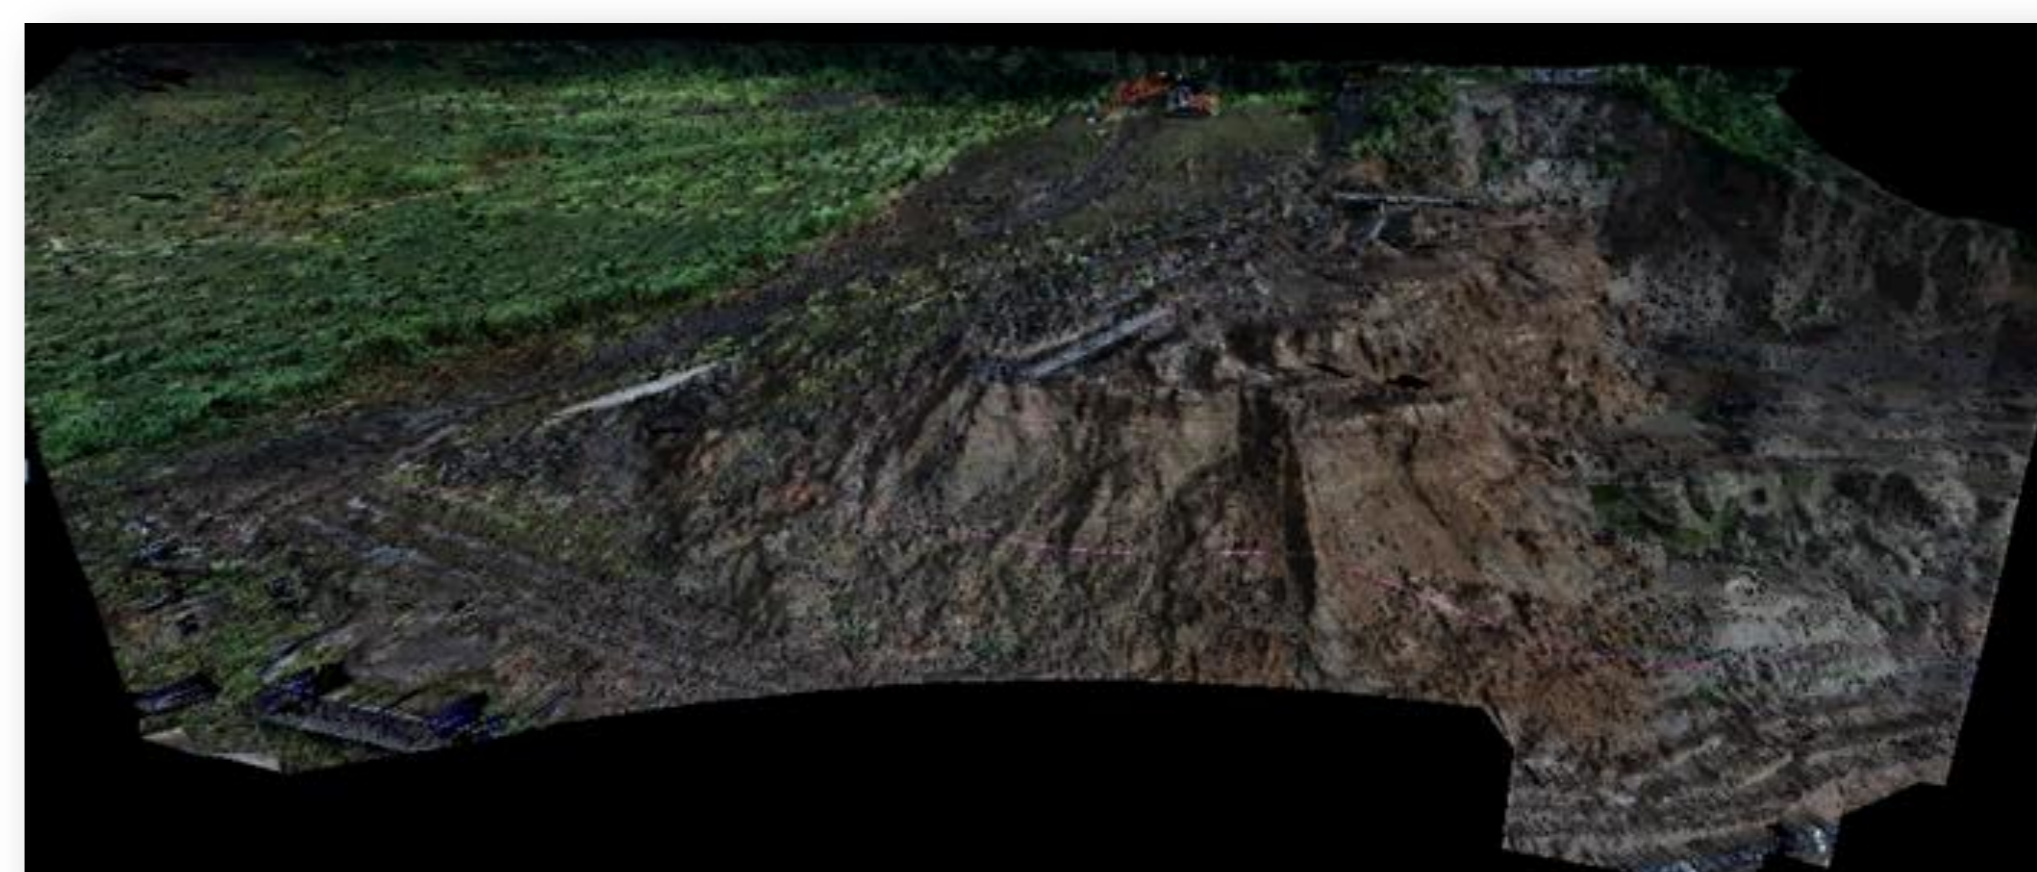
Breached dam body was LiDAR surveyed for its entire 3D image

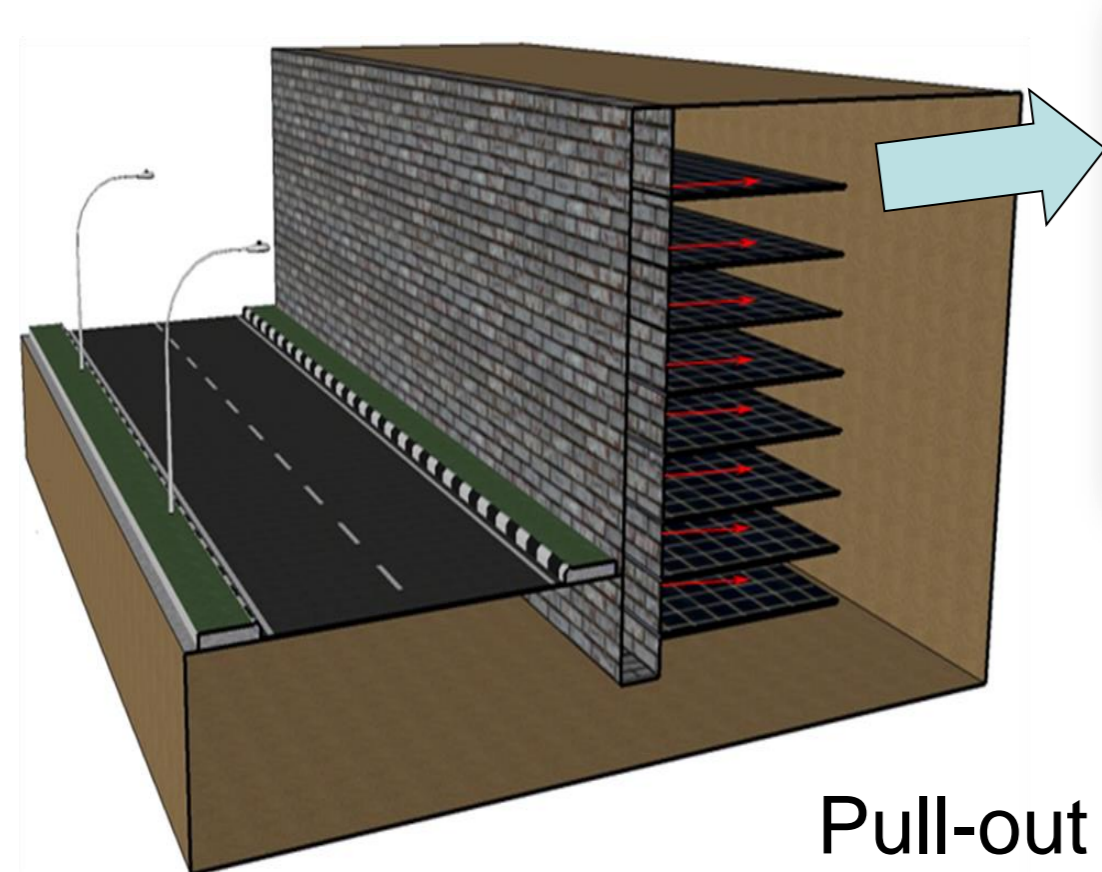
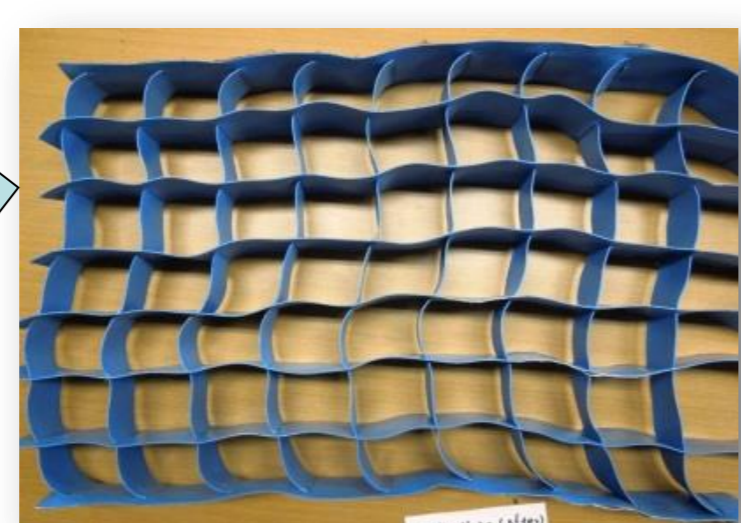
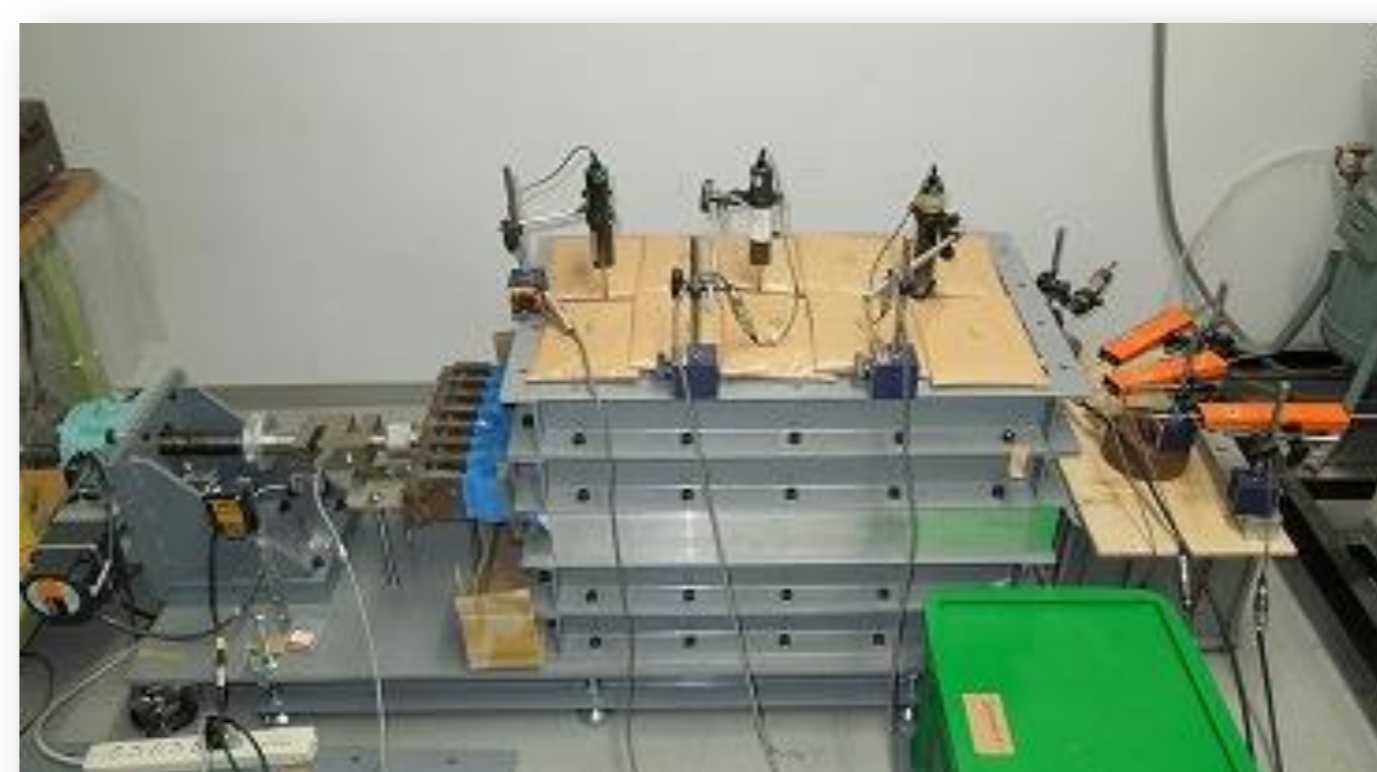
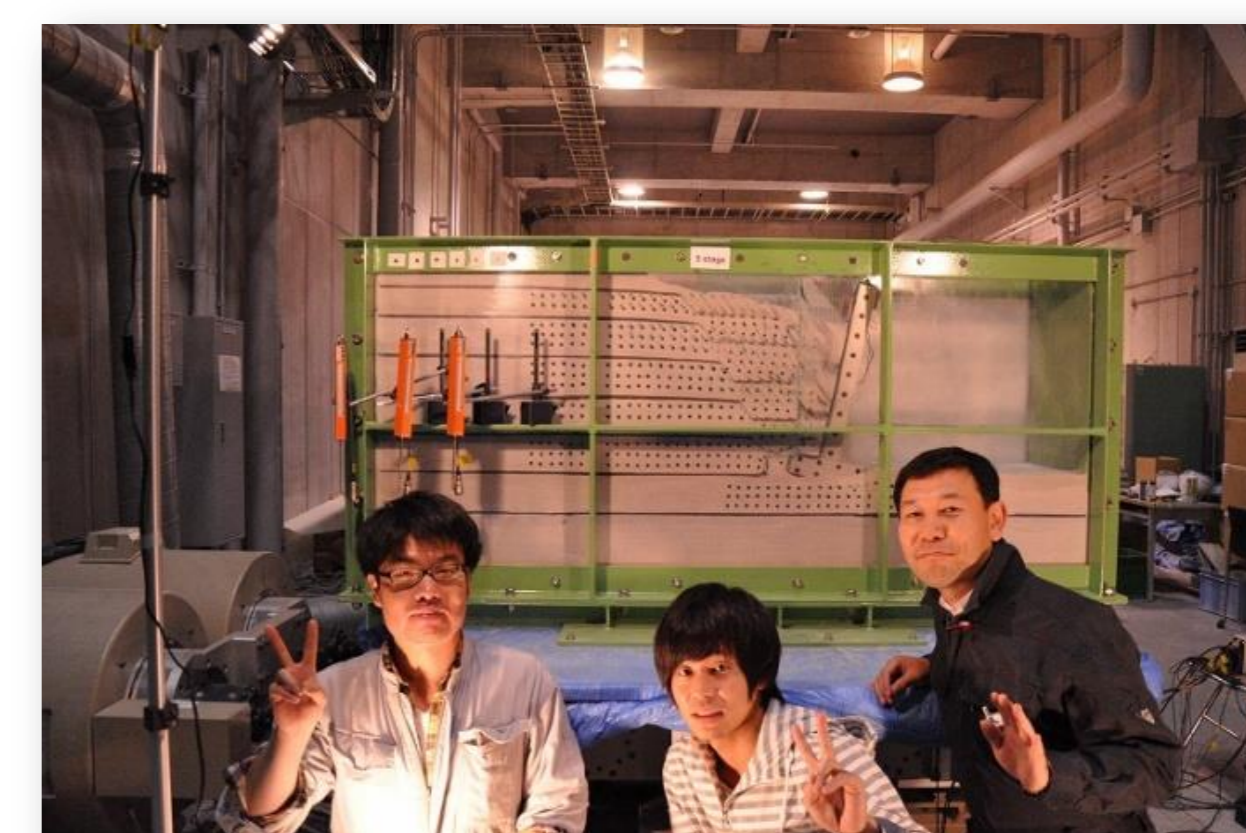
Pull-out test and shaking table model test on newly developed Geo-cell reinforced retaining wall
