KAWAGUCHI LAB.

[Spatial Structures as Architectures for Human Beings]

Safety of Large Roof Buildings

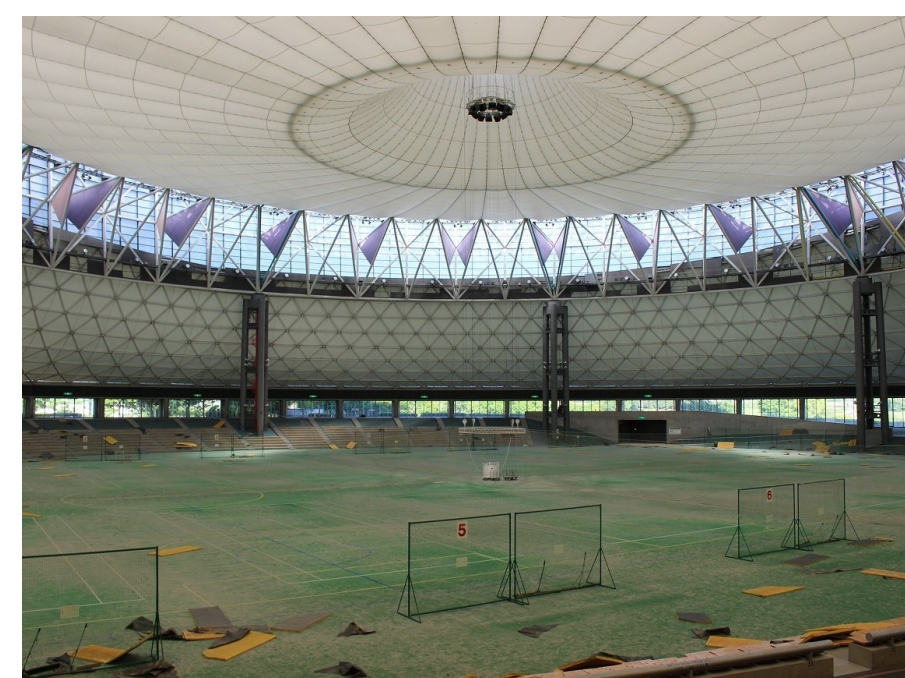
Great East Japan Earthquake

Investigation of ceiling collapse

During the main and after shocks of the East Japan Earthquake on March 11, 2011, failures of non-structural components had occurred in many large roof buildings. Harming people due to the falling of ceiling panels had occurred as well. We have been investigating the safety of large roof buildings and developing the method to prevent the falling of ceilings.

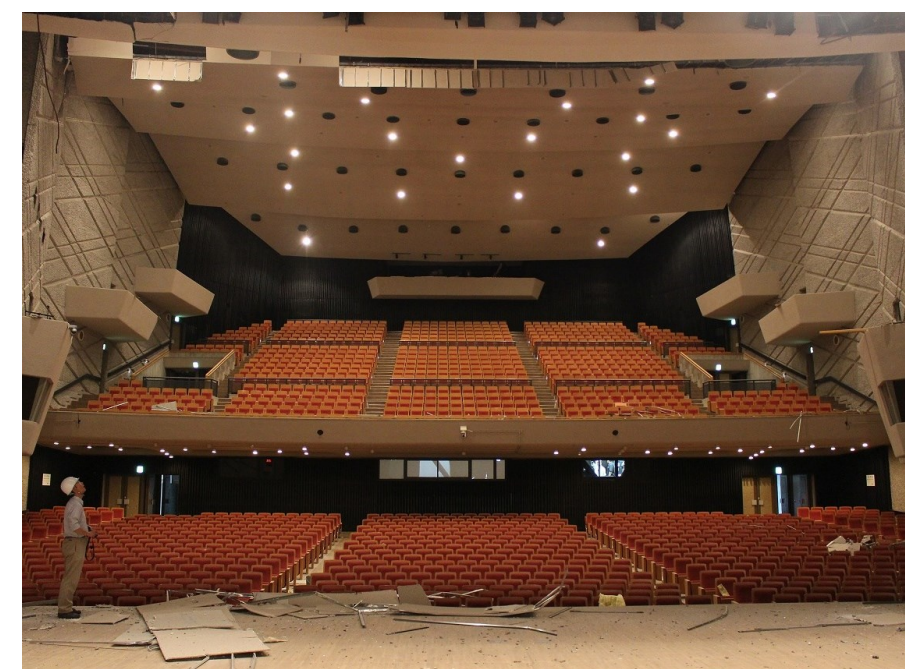
2016 Kumamoto Earthquake

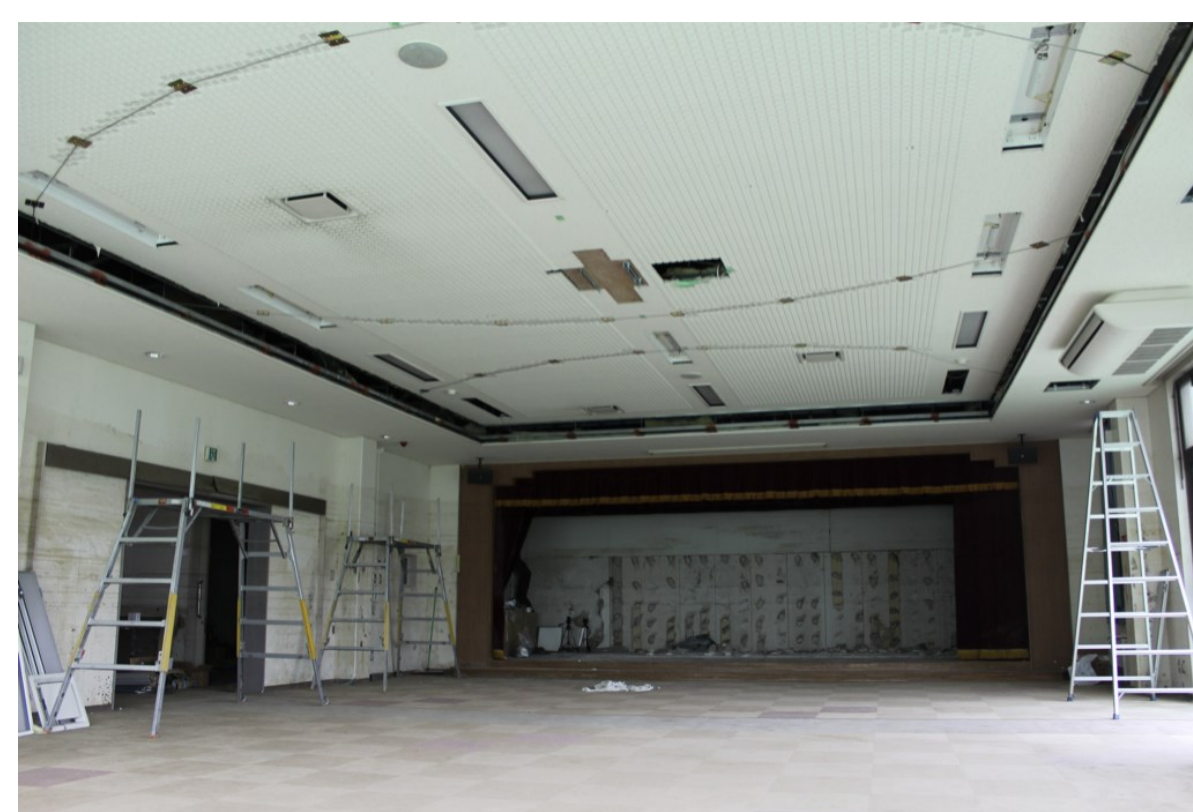
Real-scale tests of the safety net
