KIYOTA LAB.

[Geo-disaster Mitigation]

Earthquake-induced Geo-disaster

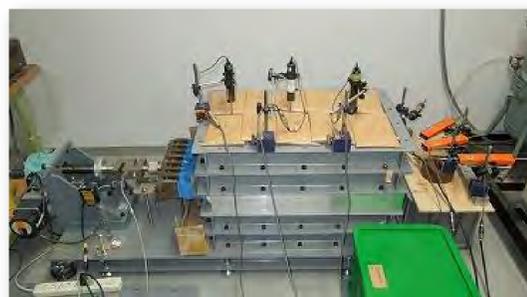
Pull-out test and shaking table model test on newly developed Geo-cell reinforced retaining wall
