NAKANO LAB.

[Seismic Damage Estimation of RC Building Structure]

Damage Estimation of Reinforced Concrete Building Structures During Earthquakes

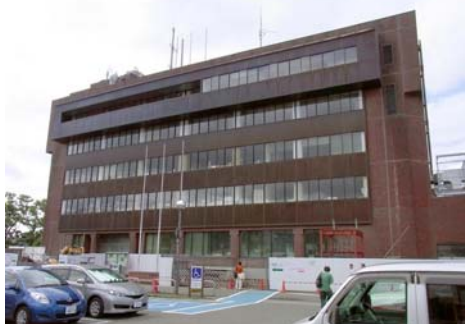
Susono city hall, Shizuoka

Changes of the Vibrational Characteristics in... 2008: original design
2010: under construction
2011: seismic retrofit
