# KAWAGUCHI LAB.

## [Spatial structures as architectures for human beings]

## Safety of Large Roof Buildings

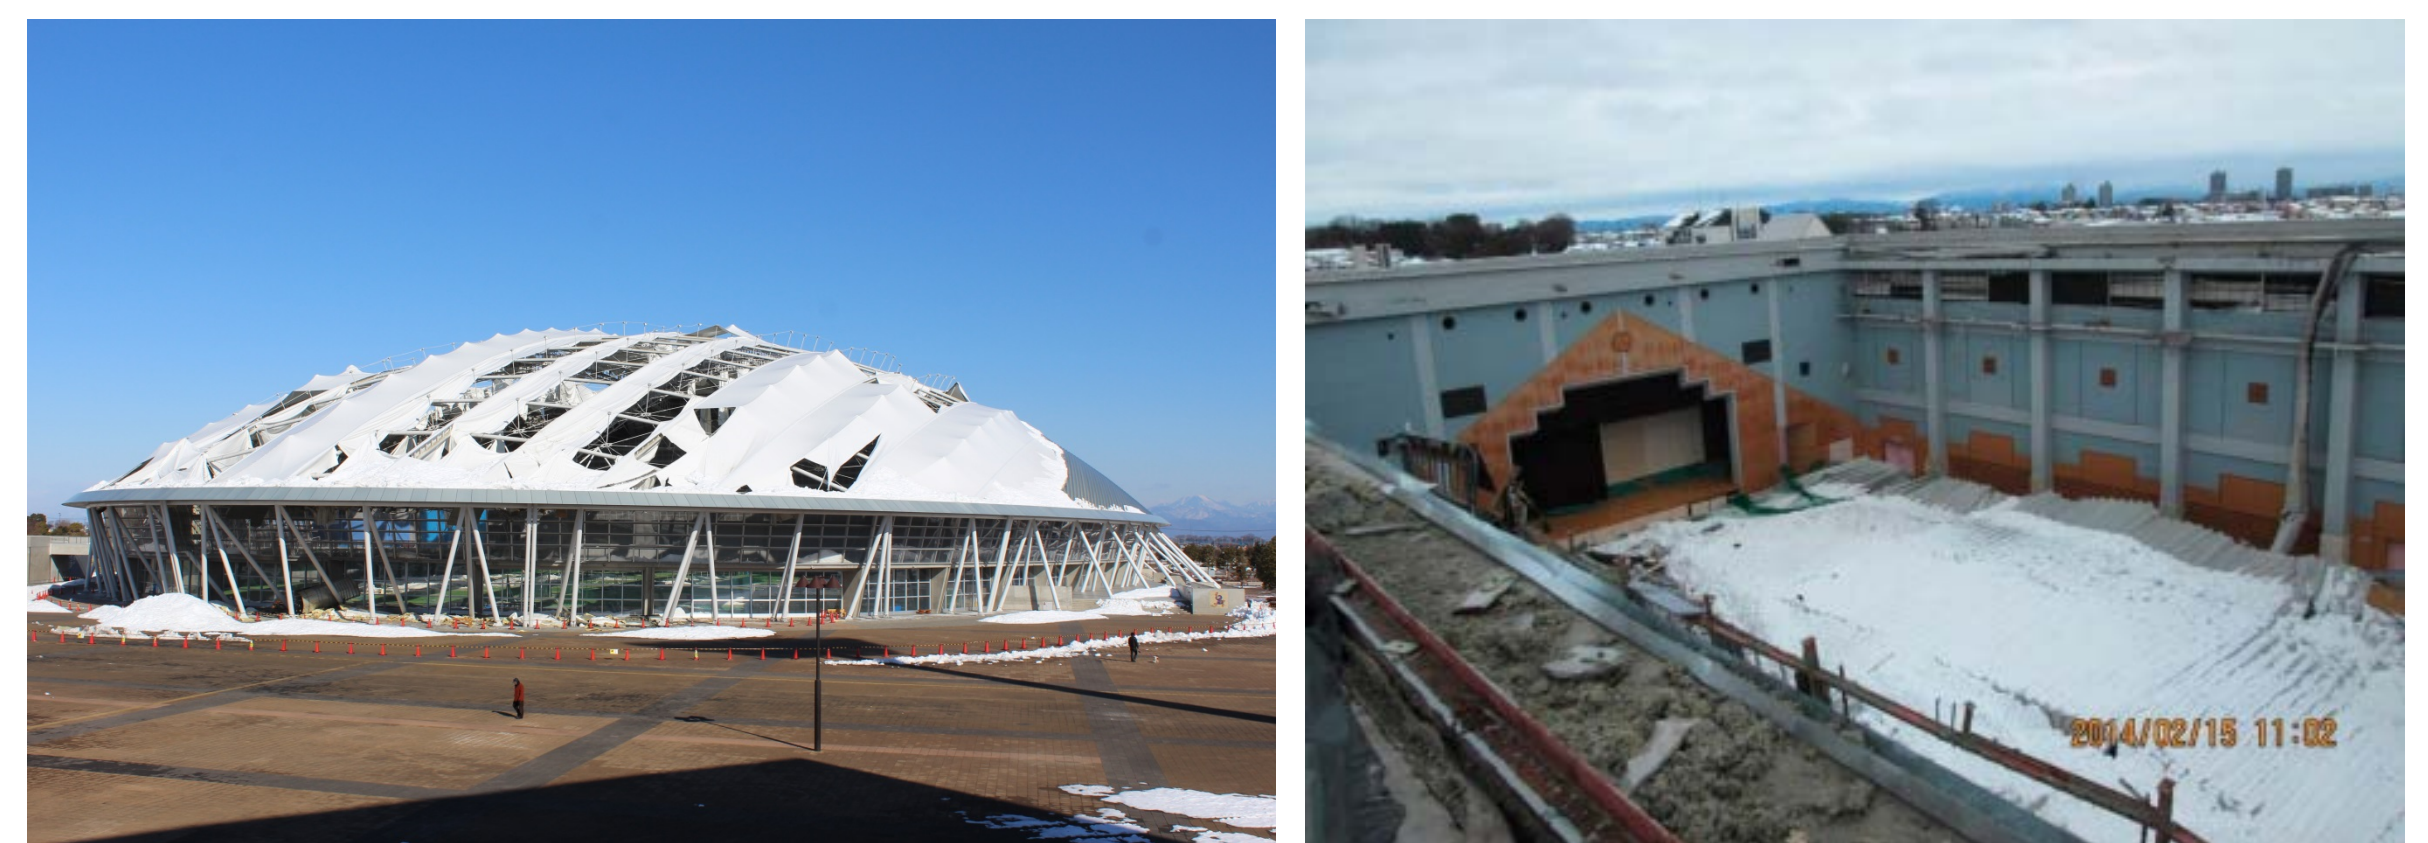
Roof collapse due to the heavy snowfall on Feb. 14, 2014

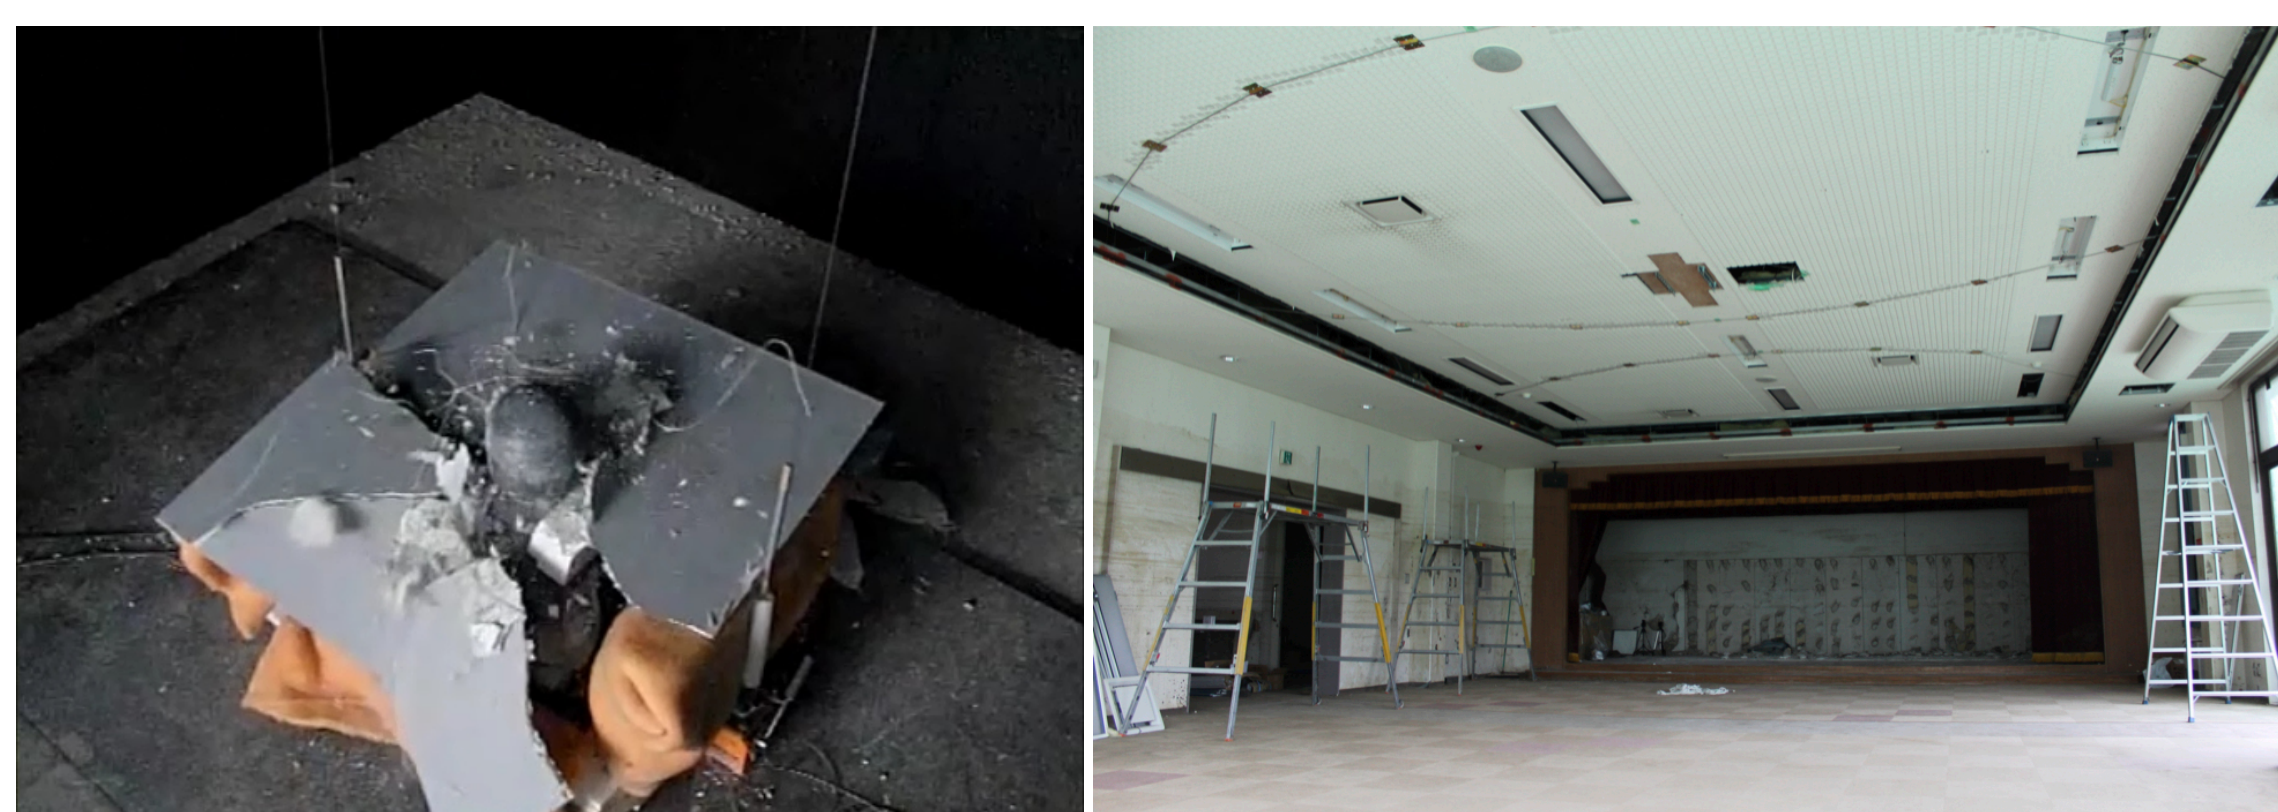
Safety assessment of ceilings by dropping experiments

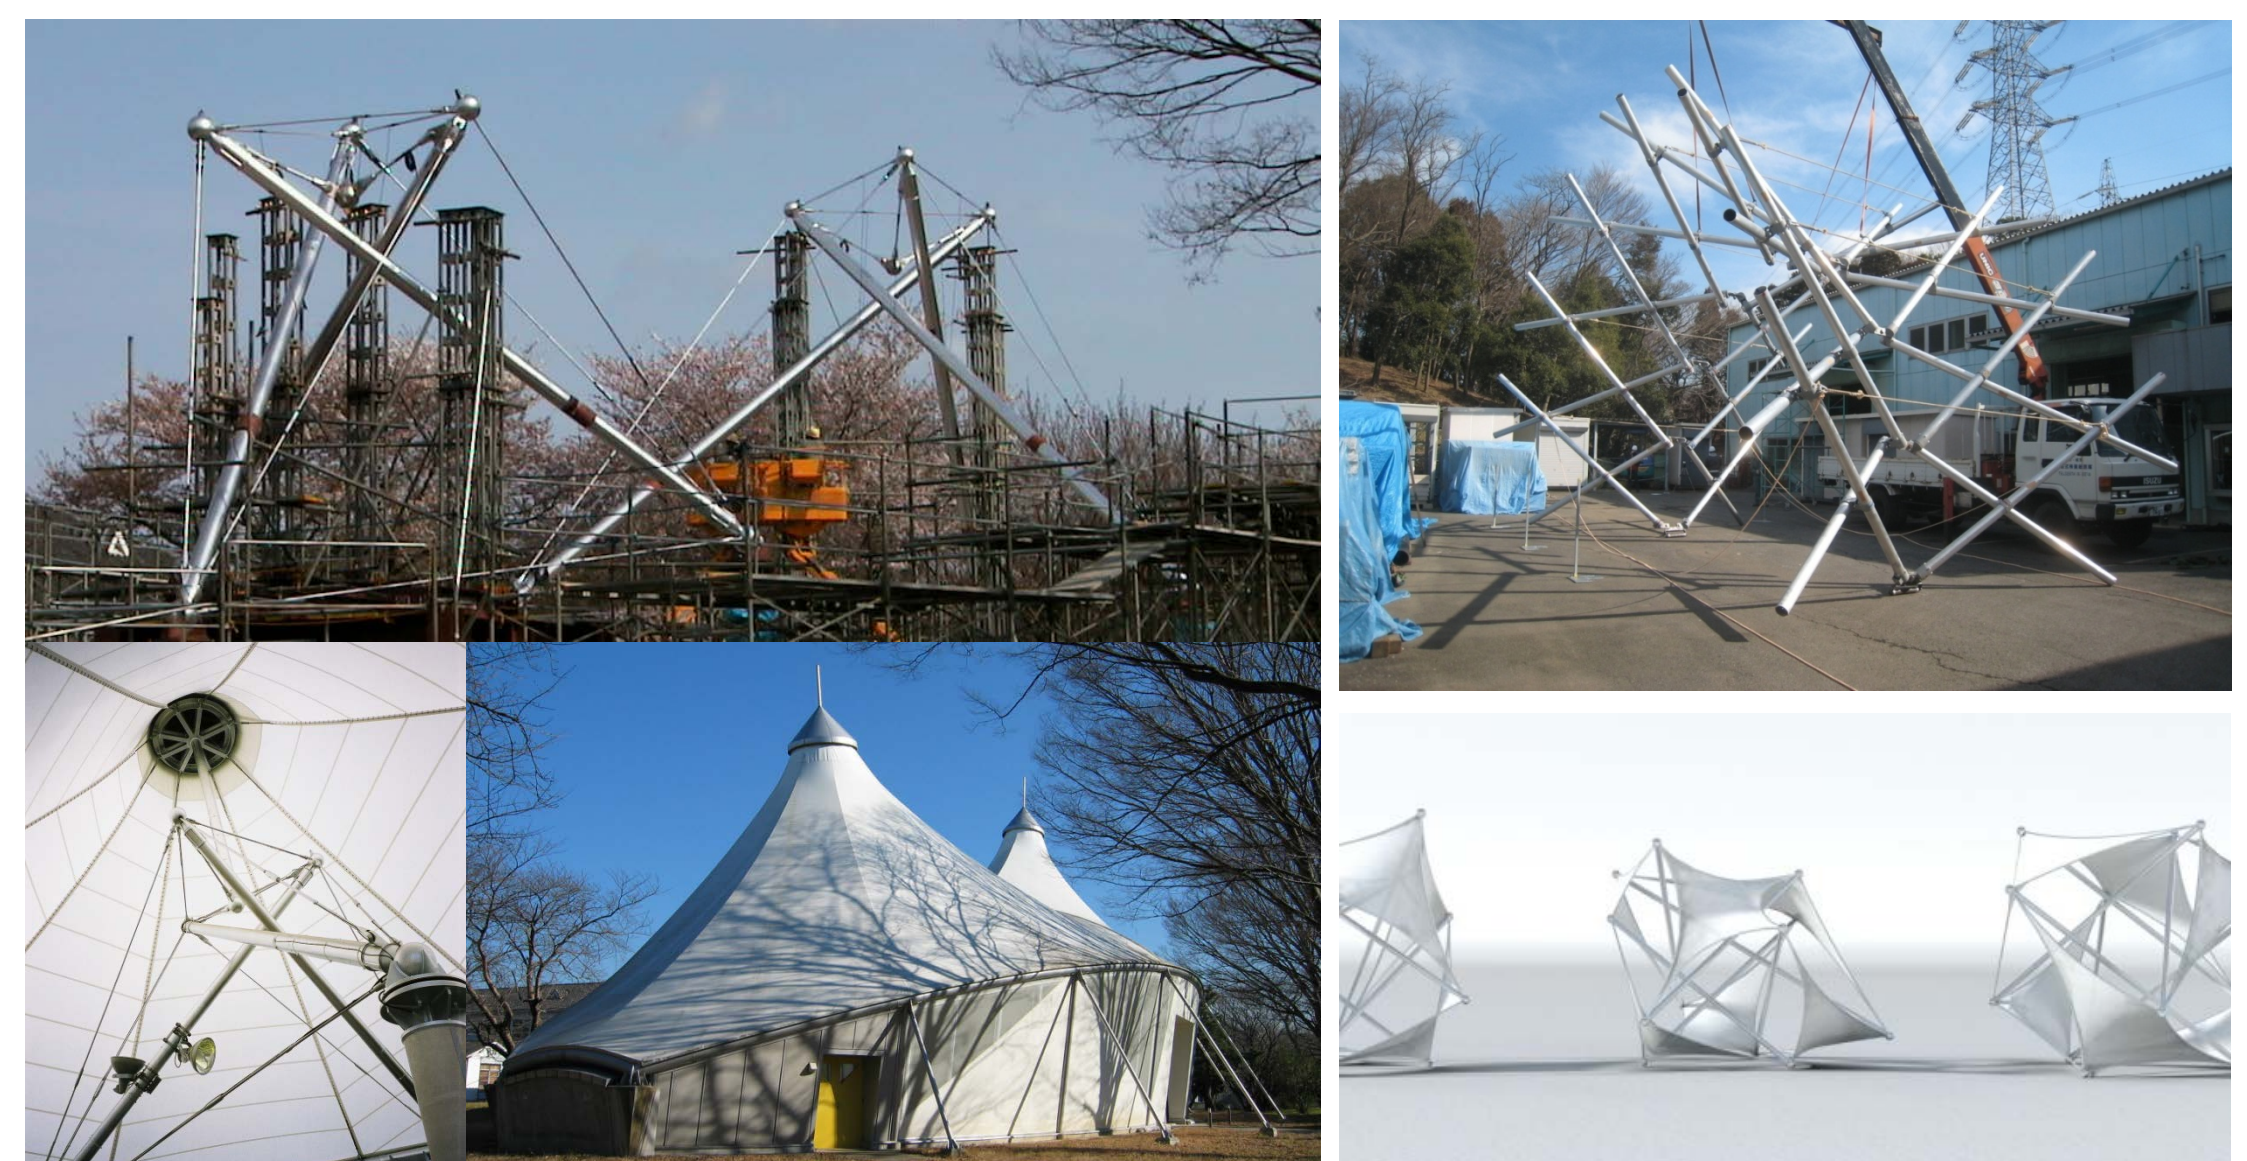
Ceiling reinforcement using cable
