# KAWAGUCHI LAB.

## [Spatial Structures as Architectures for Human Beings]

## Safety of Large Roof Buildings

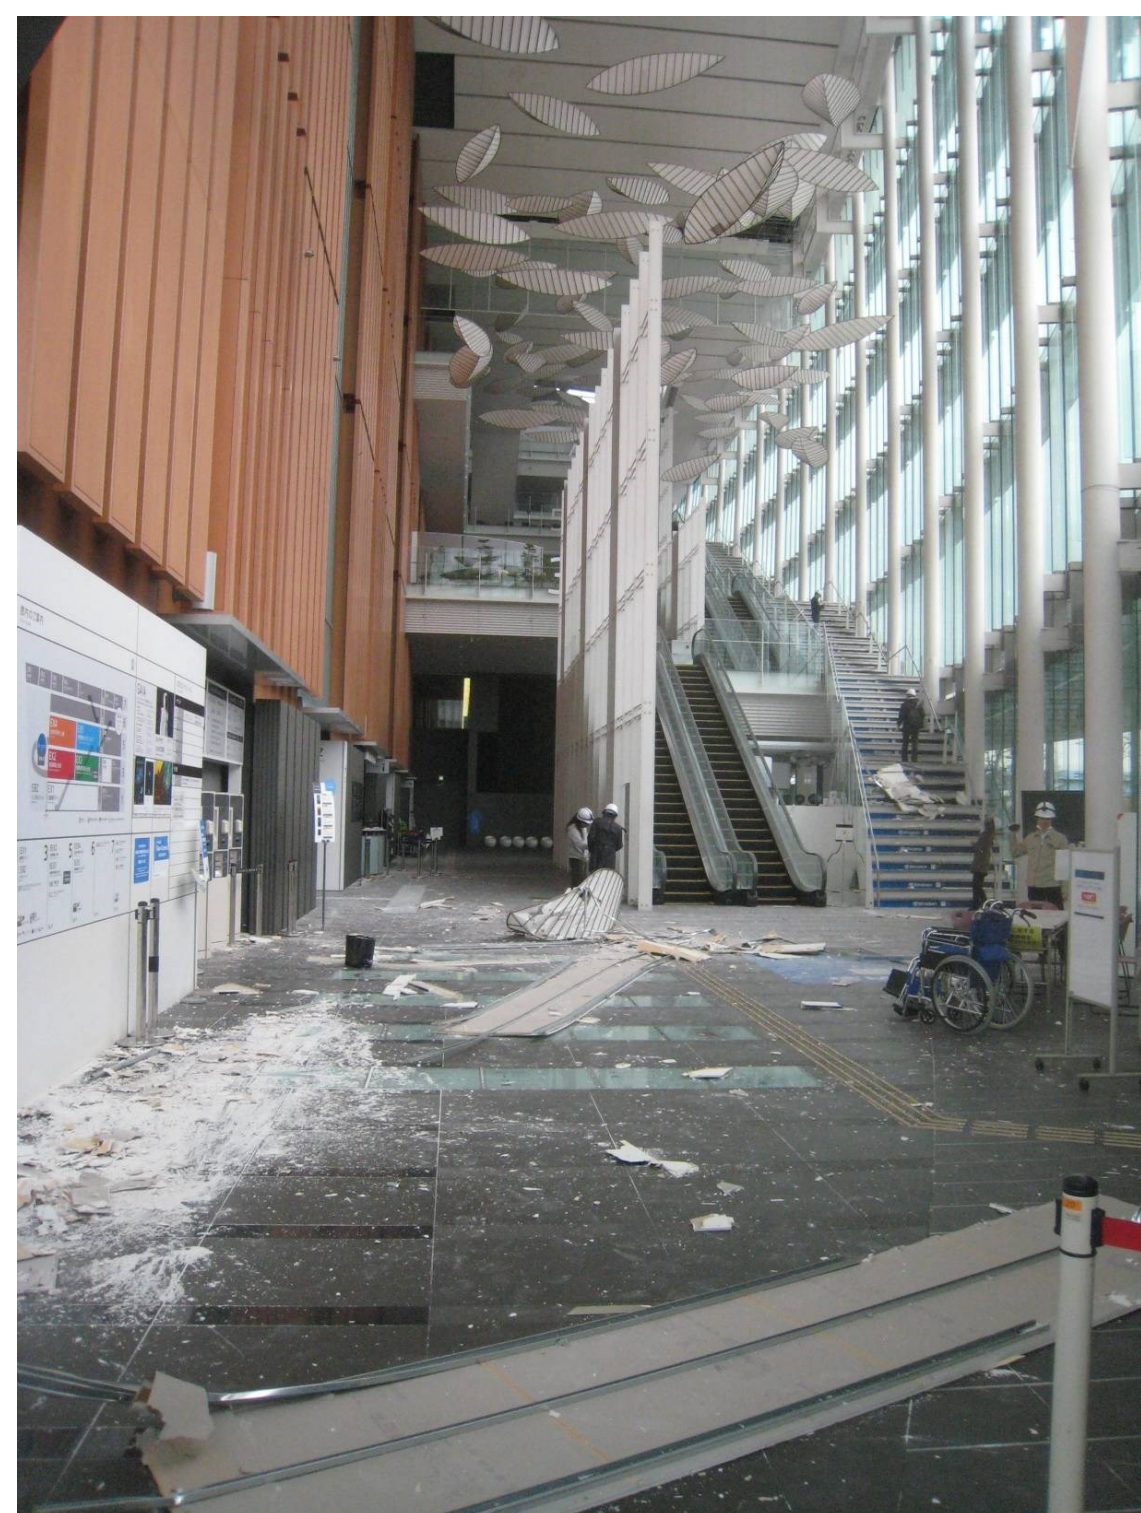
Great East Japan Earthquake

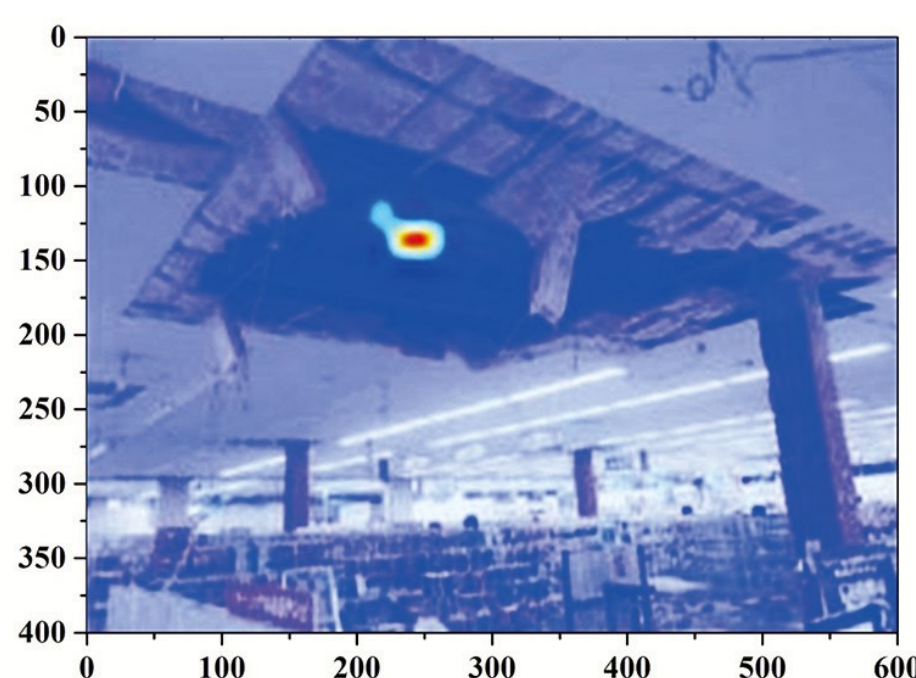
Failure Detection with AI

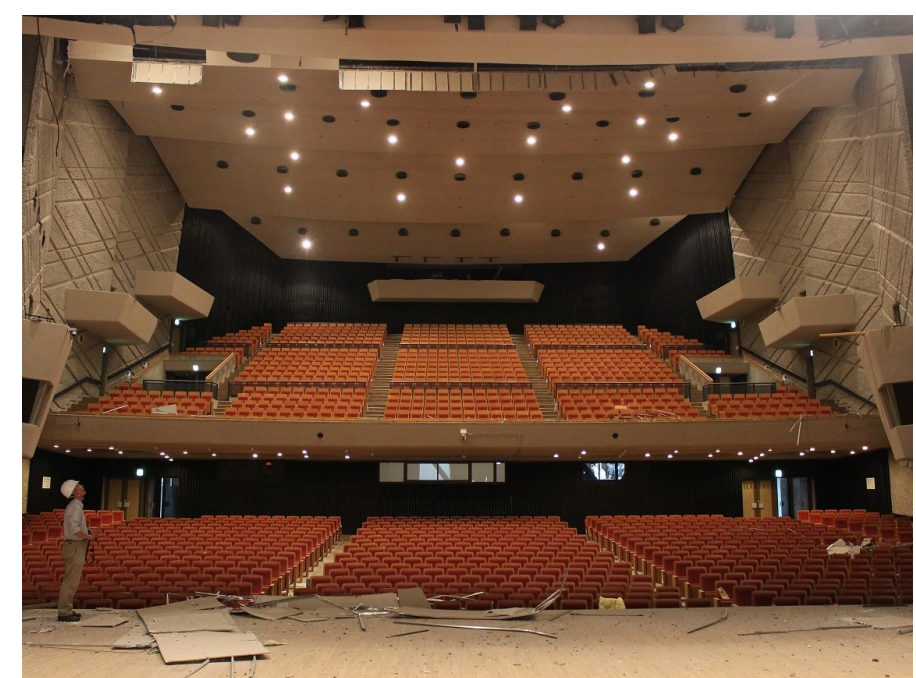
2016 Kumamoto Earthquake

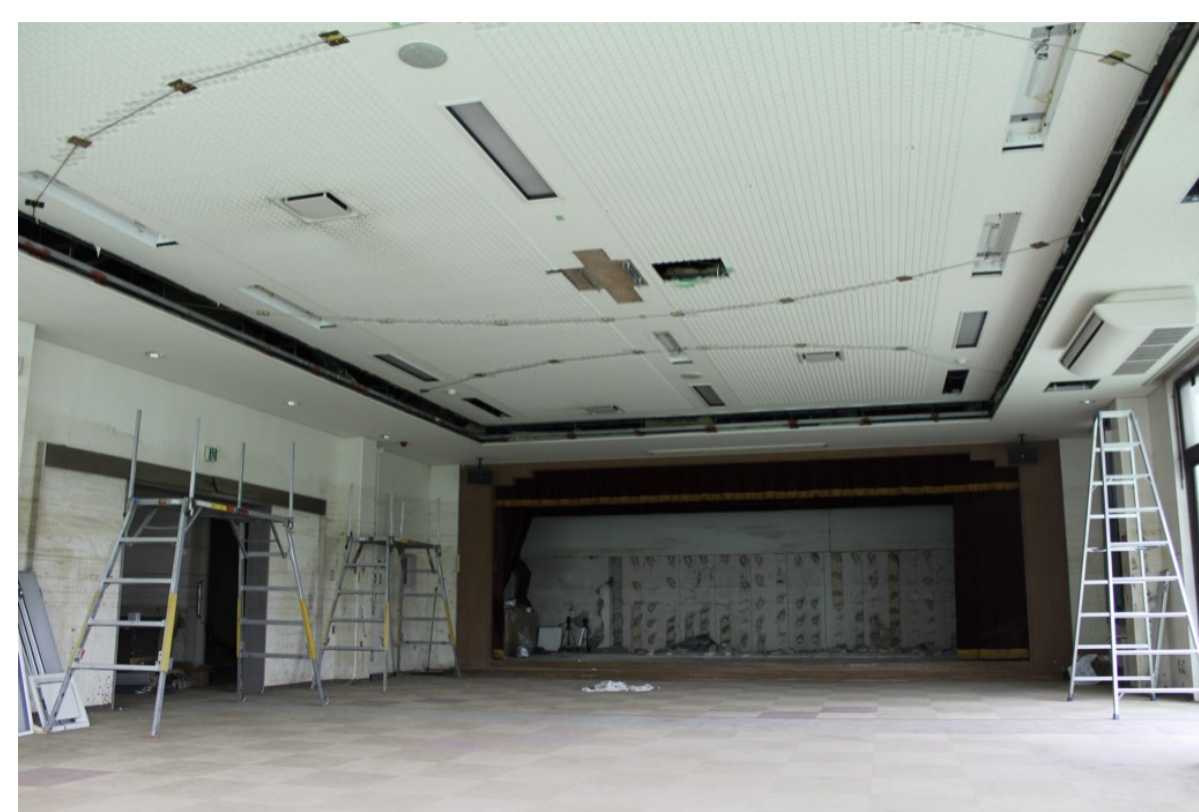
Ceiling reinforcement with cables

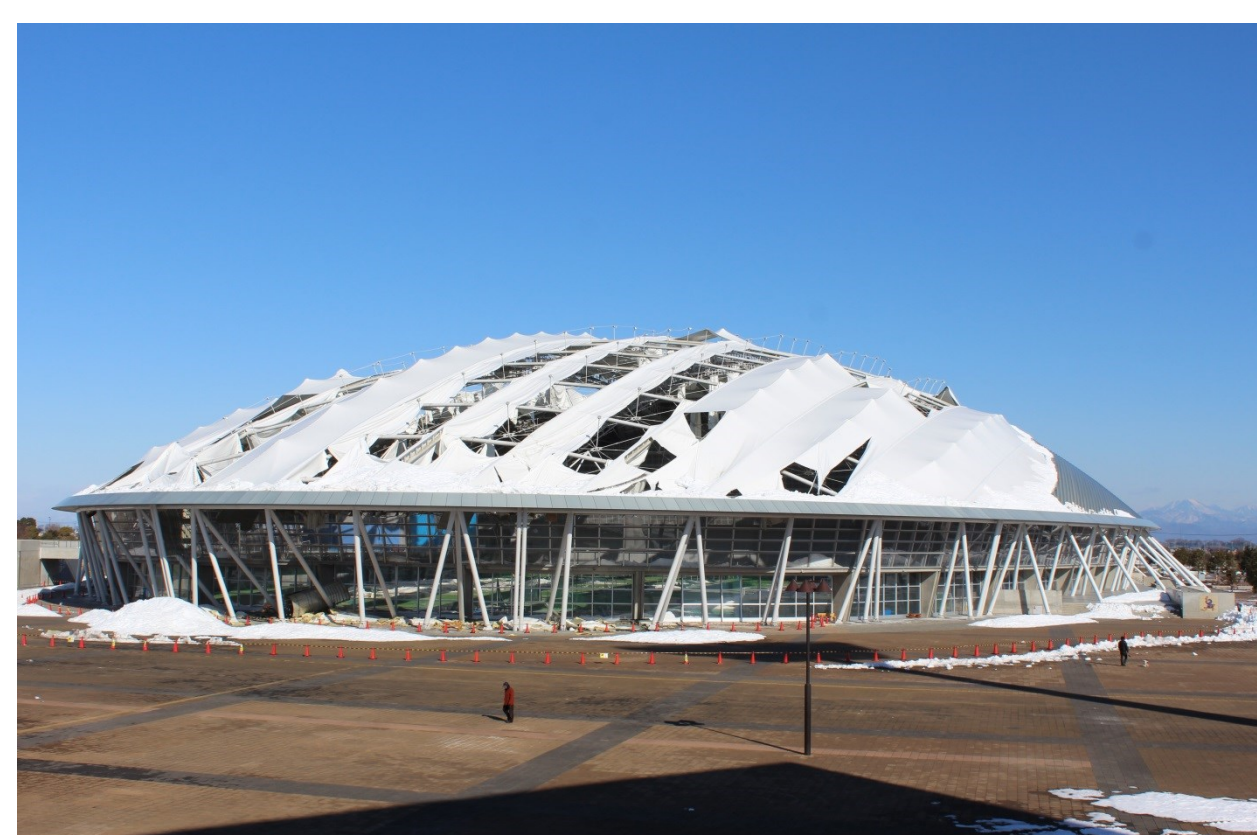
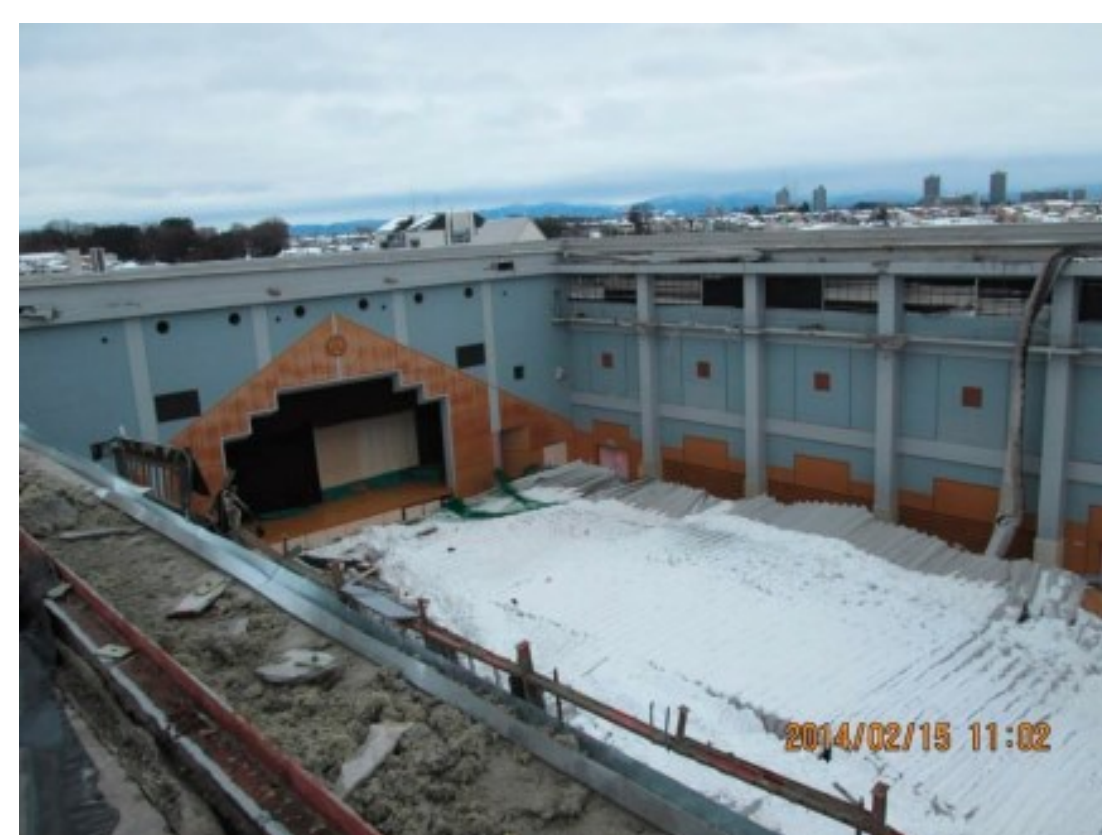
Roof collapse due to the heavy snowfall on Feb. 14, 2014
