KIYOTA LAB.

[Challenge of Geo-disaster Mitigation]

Geo-disaster Mitigation Engineering

Earthquake-induced Geo-disaster

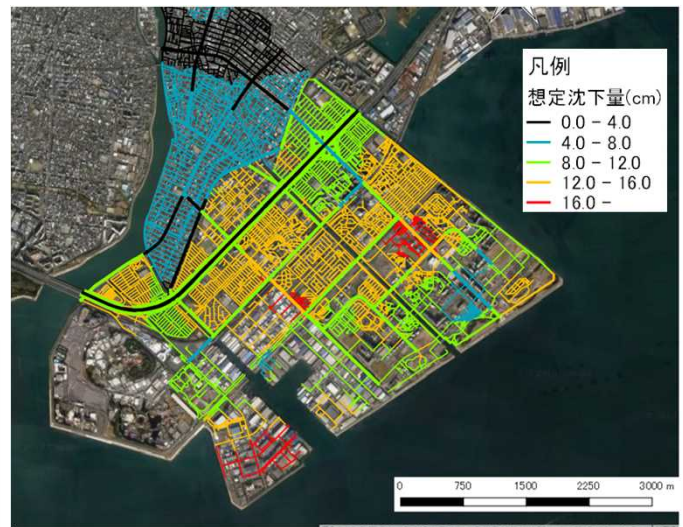
Newly-developed liquefaction hazard map for road network in Urayasu City

Field investigation and laboratory test on liquefaction problem
