KIYOTA LAB.

[Challenge of Geo-disaster Mitigation]

Geo-disaster Mitigation Engineering

Earthquake-induced Geo-disaster

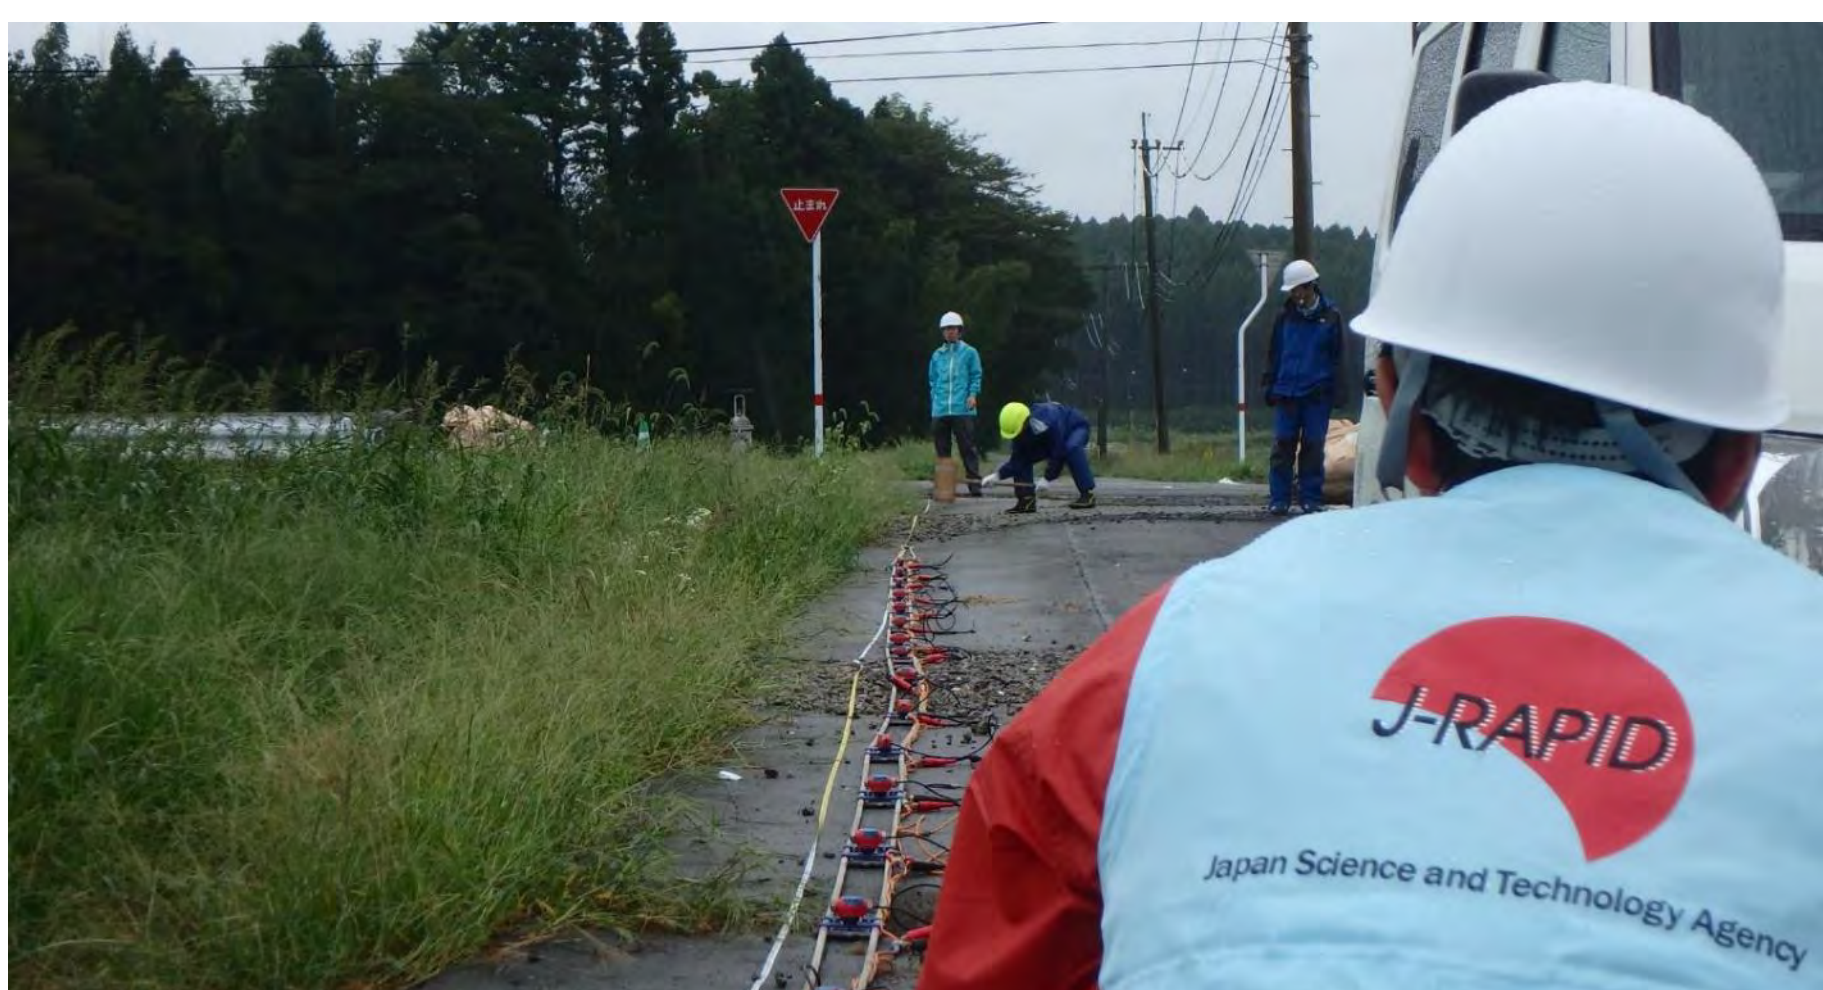
Field investigation and laboratory test on liquefaction problem
