KAWAGUCHI LAB.

[Spatial Structures as Architectures for Human Beings]

Safety of Large Roof Buildings

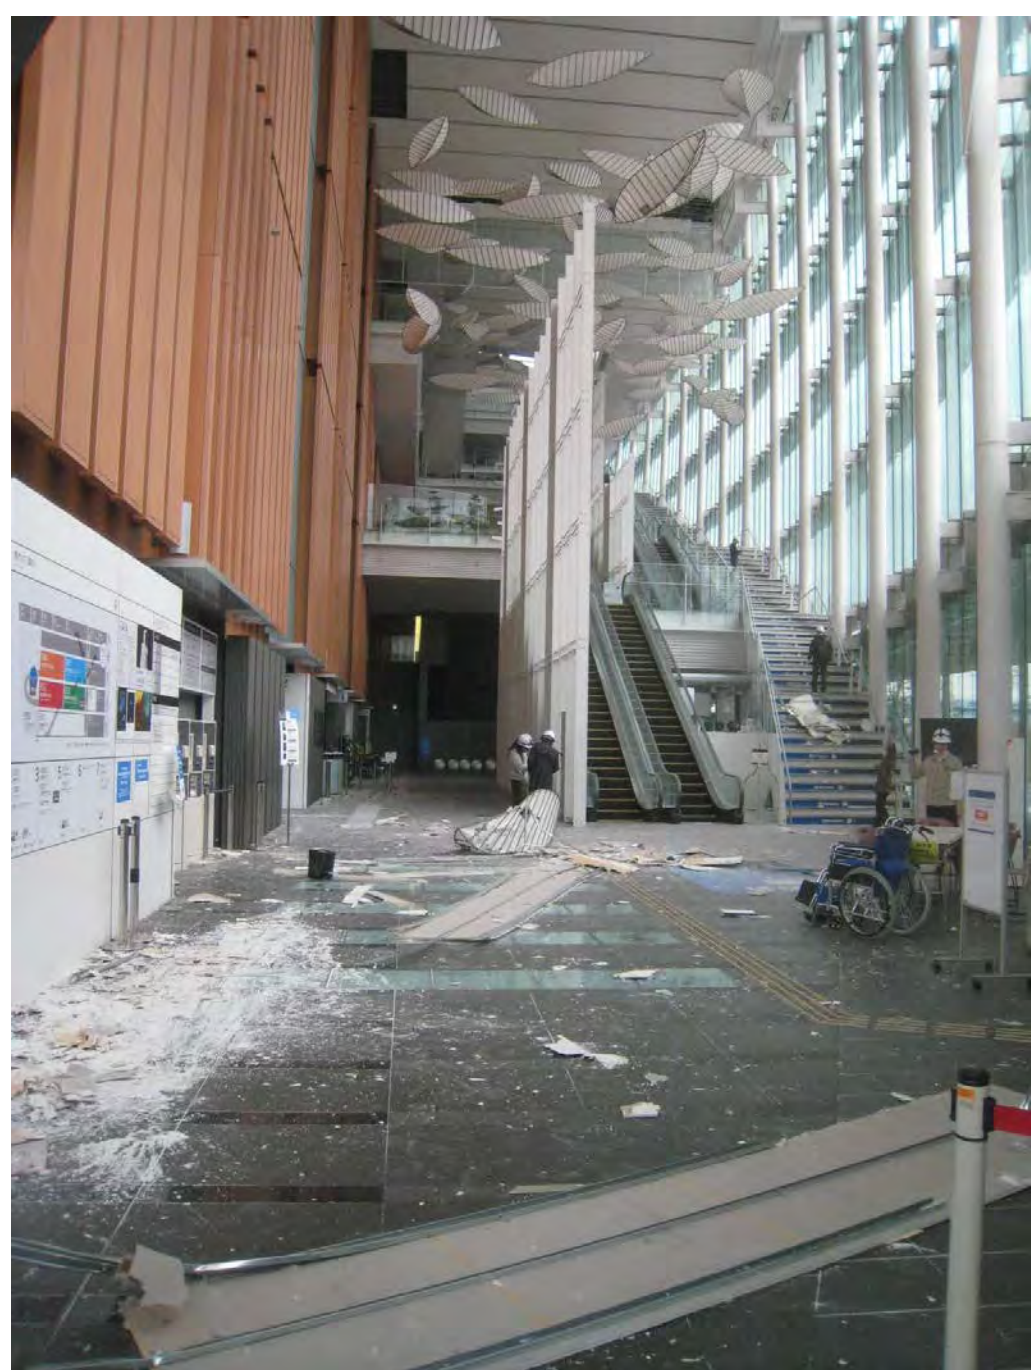
Great East Japan Earthquake

During the main and after shocks of the East Japan Earthquake on March 11, 2011, failures of non-structural components had occurred in many large roof buildings. Harming people due to the falling of ceiling panels had occurred as well. We have been investigating the safety of large roof buildings and developing the method to prevent the falling of ceilings.

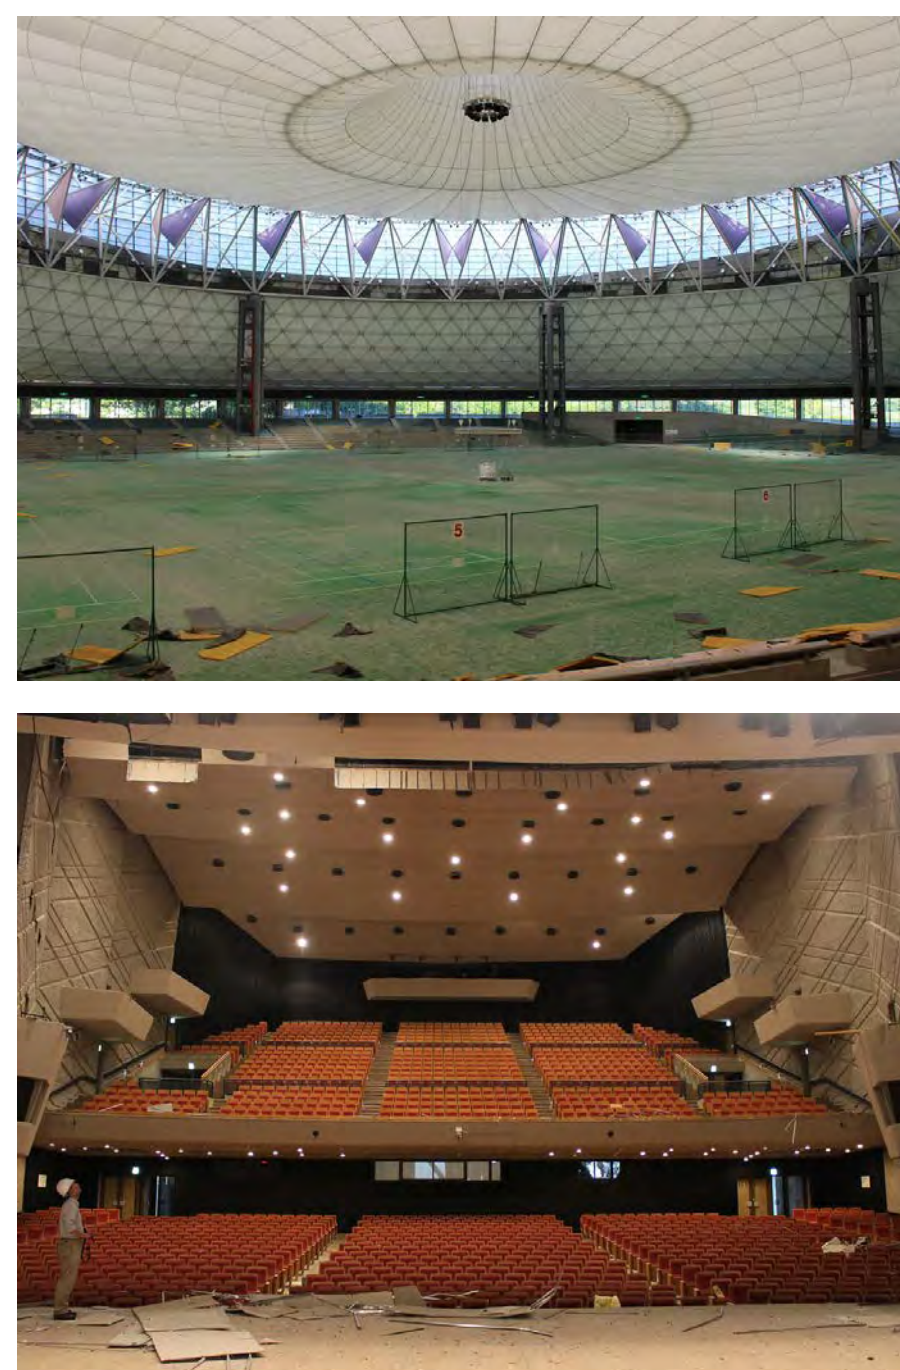
2016 Kumamoto Earthquake

Investigation of ceiling collapse

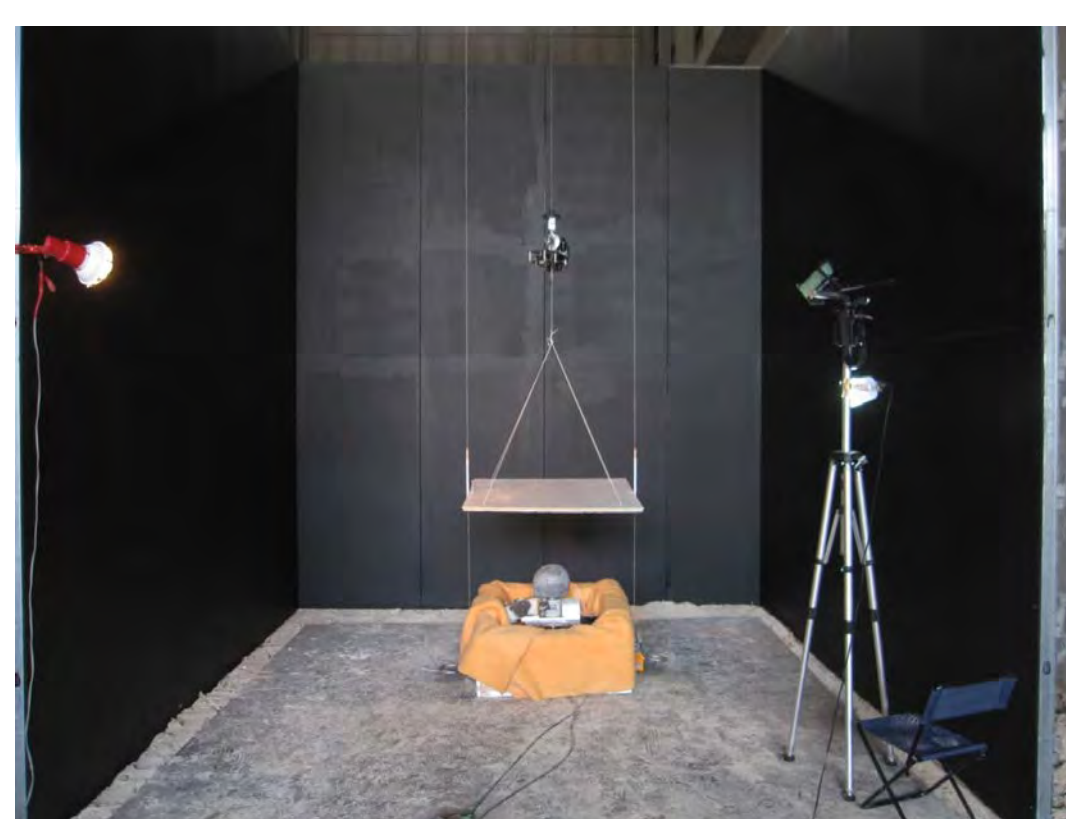
Safety assessment of ceilings by ceiling drop tests

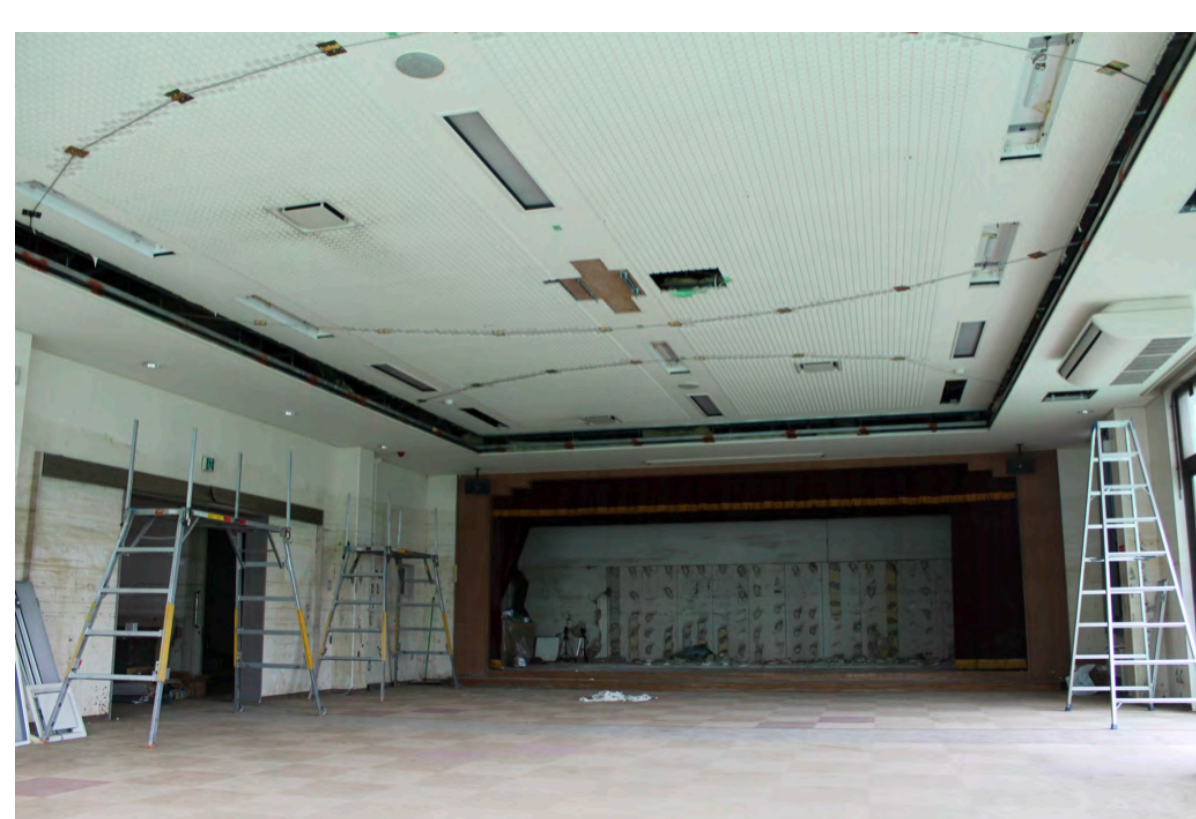
Ceiling reinforcement with cables

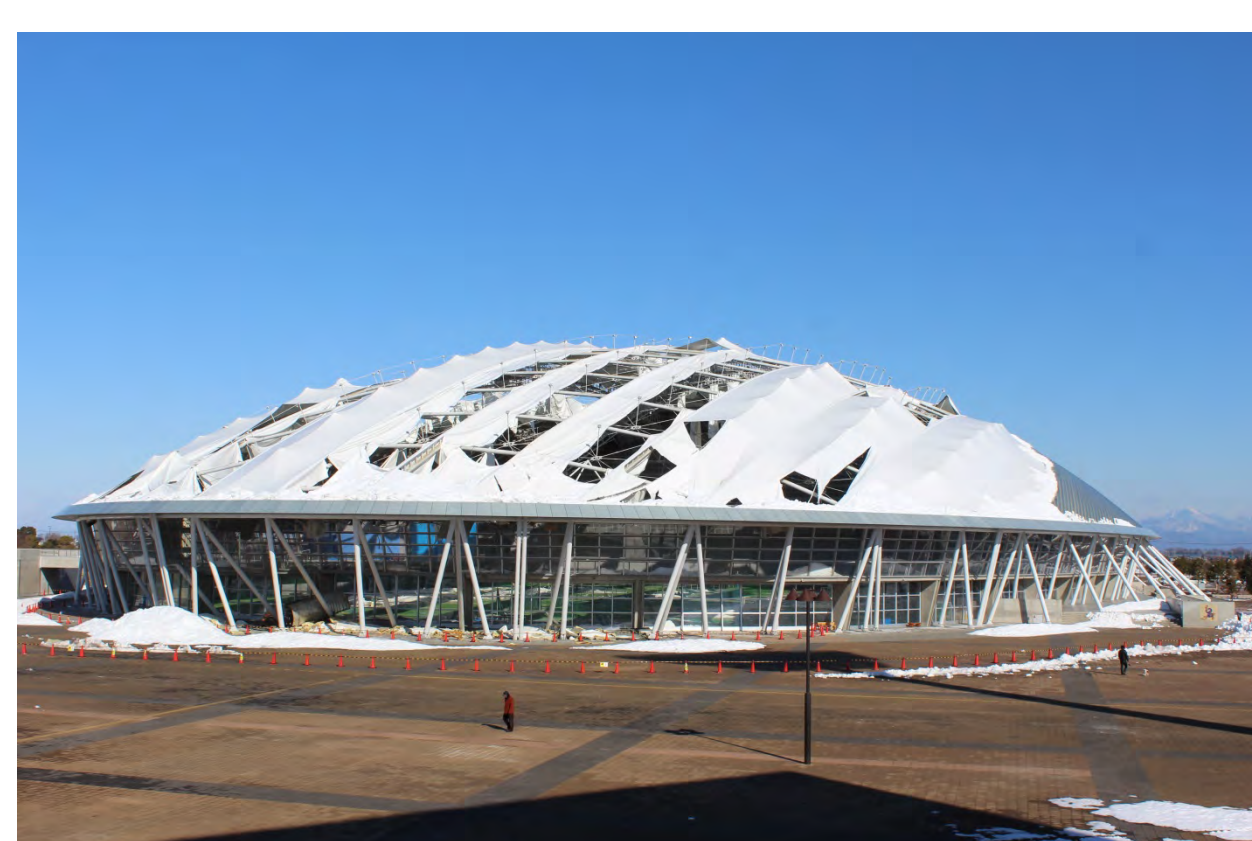
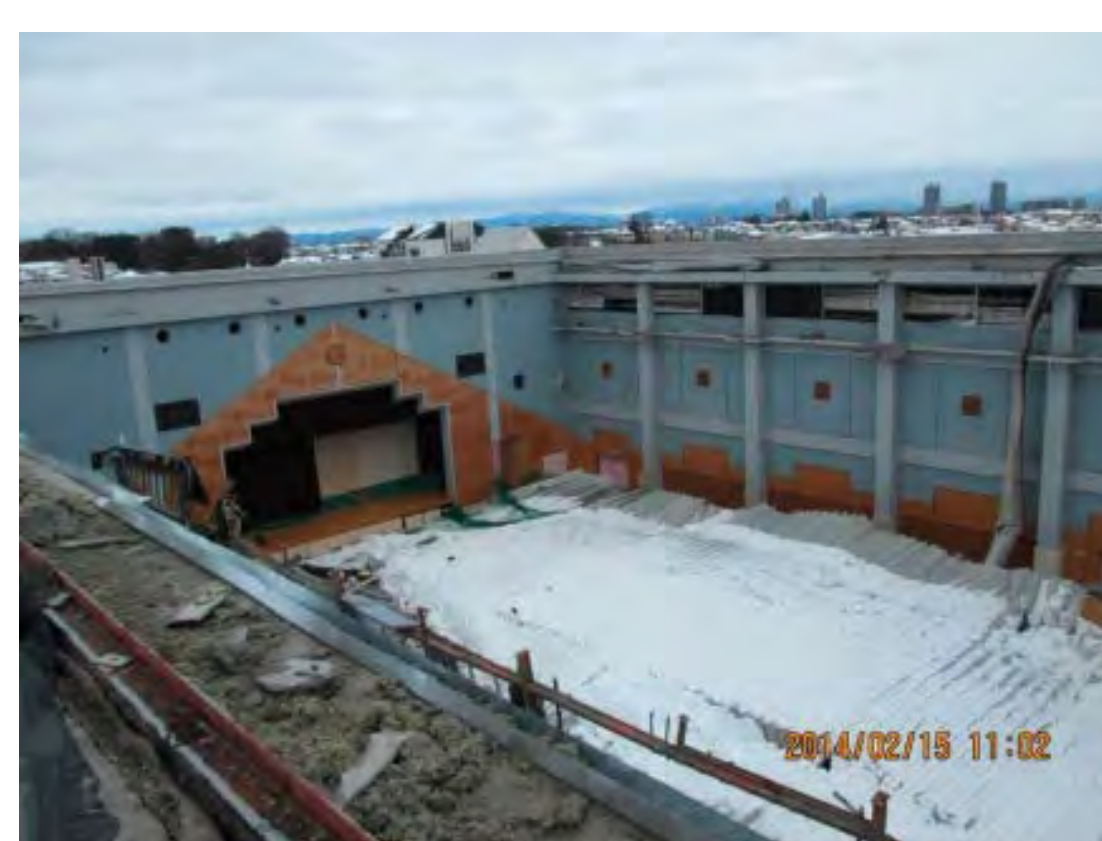
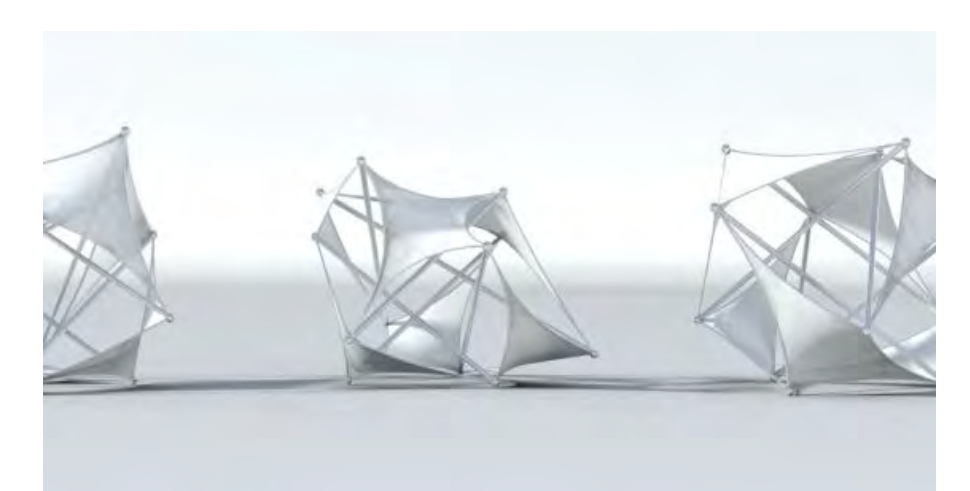
Roof collapse due to the heavy snowfall on Feb. 14, 2014
