KUWANO LAB.

[Prevention of Ground Cave-in]

Geotechnical and Geo-environmental Engineering

Hidden Cavity in the Ground Causing Ground Cave-in

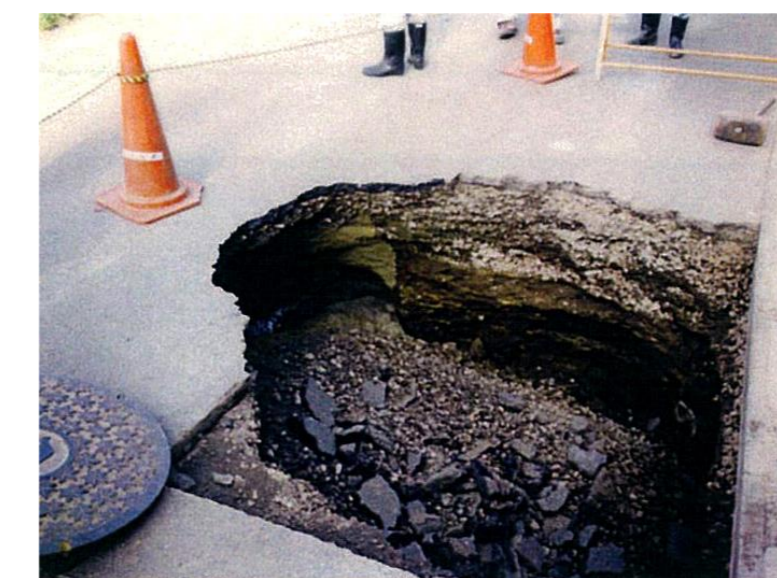
Road cave-in due to corrosion of sewer pipe

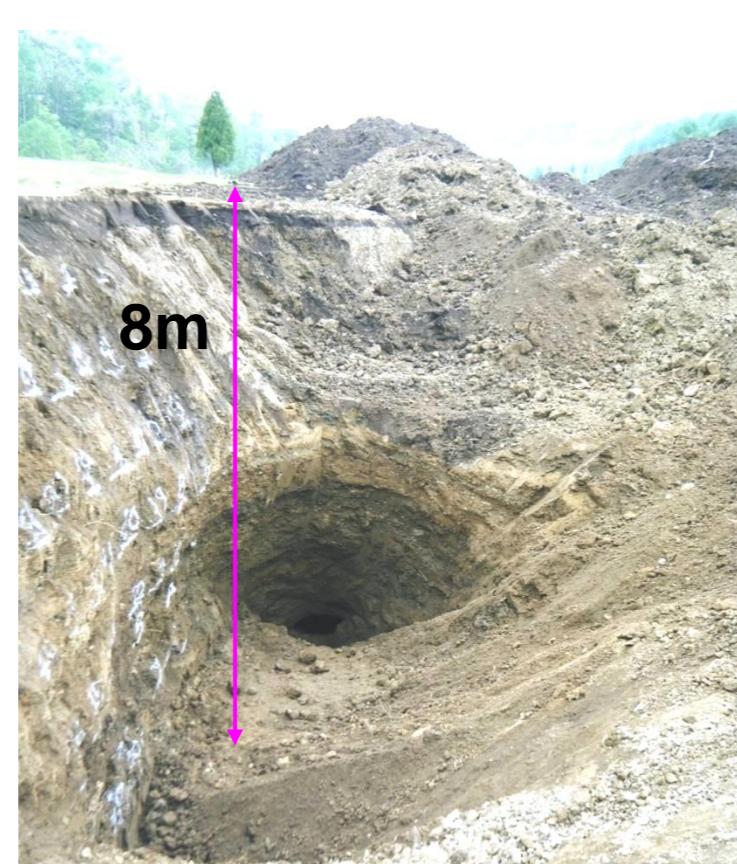
Hidden cavity in the ground
