[Prevention of Ground Cave-in]

International Center for Urban Safety Engineering

Hidden Cavity in the Ground Causing Ground Cave-in

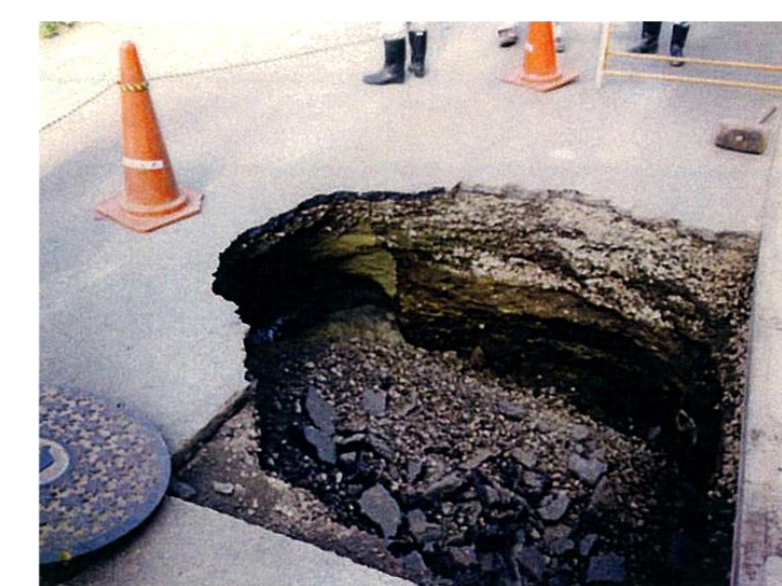
Road cave-in due to corrosion of sewer pipe

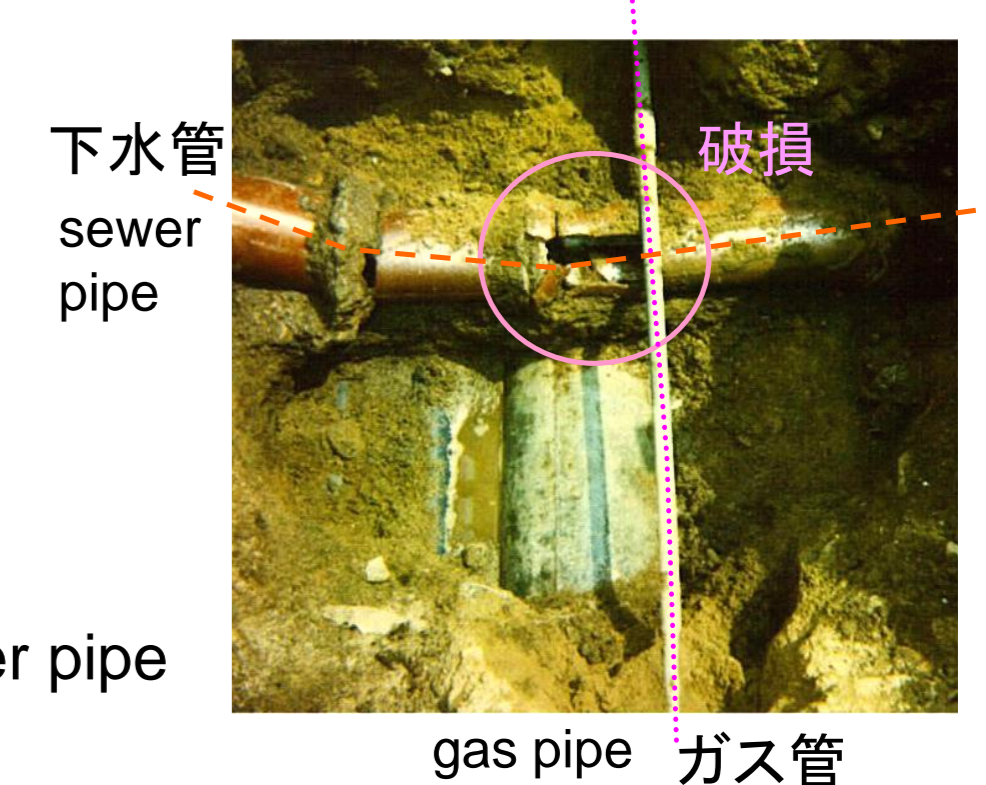
Damaged sewer pipe

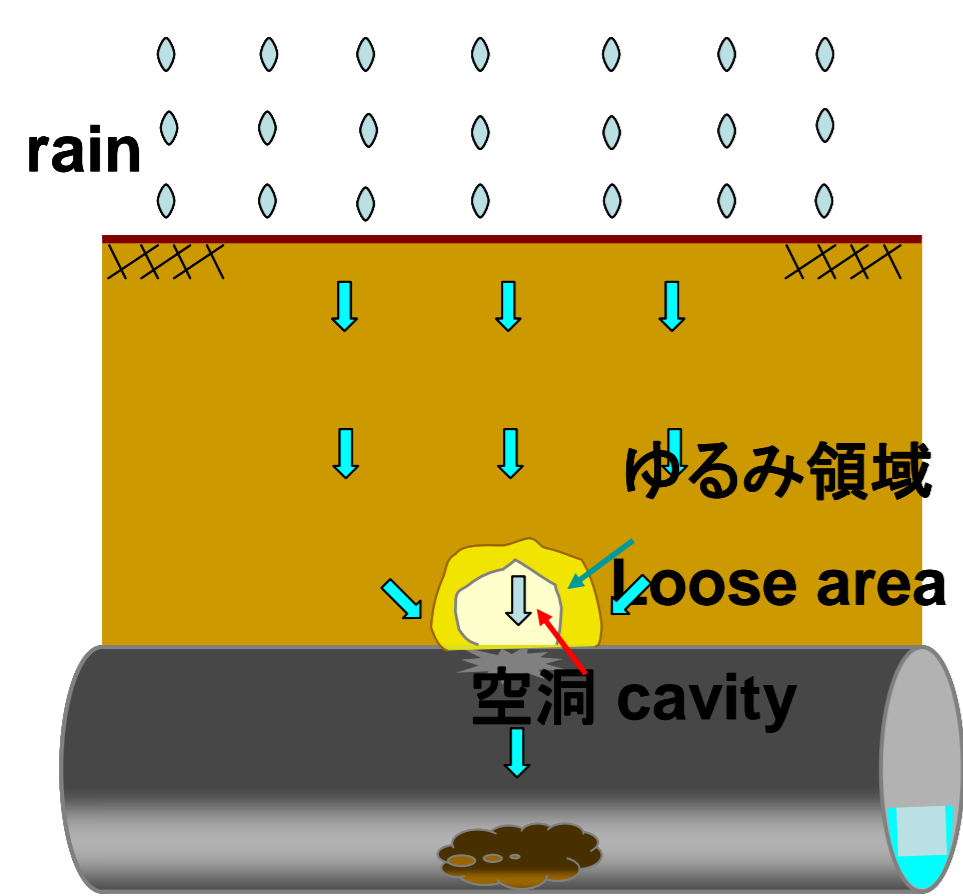
Model test simulating ground cavity formation

Subsurface erosion above the defects of buried pipe

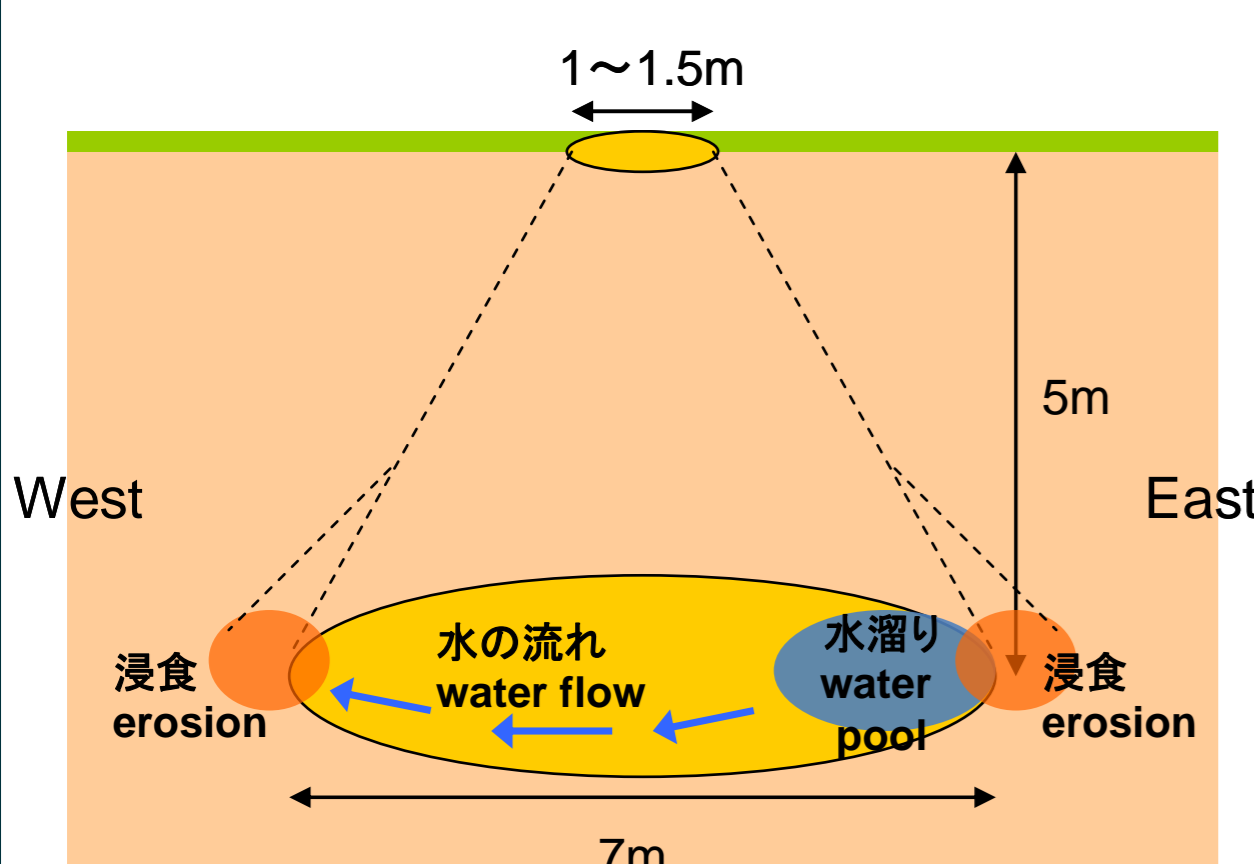
Cave-in accident in Hokkaido Abira-town golf course (2009 April)

Hidden cavity in the ground

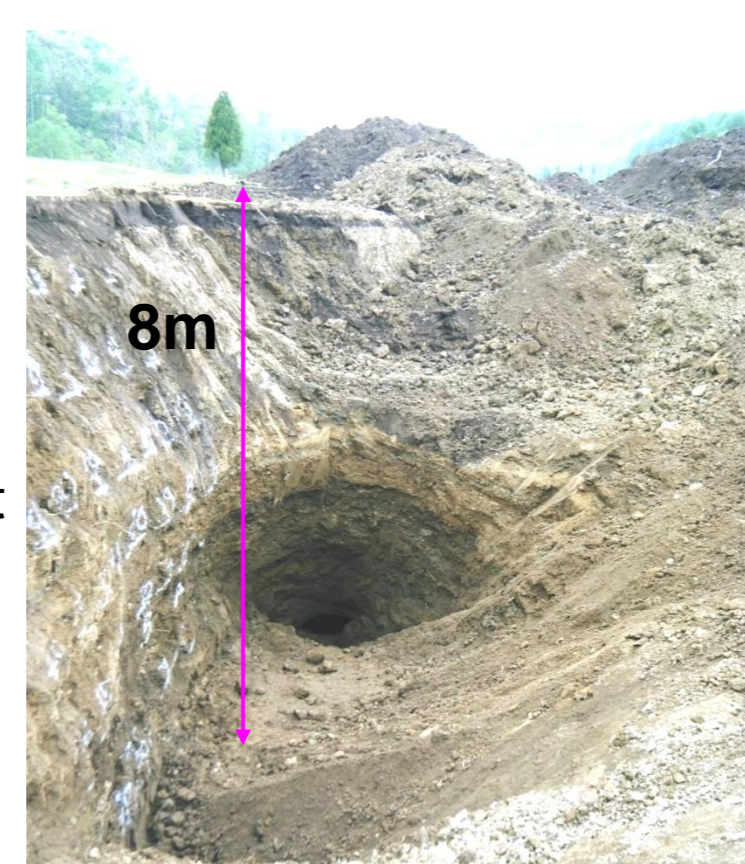
Soil pipe found at the location of cave-in

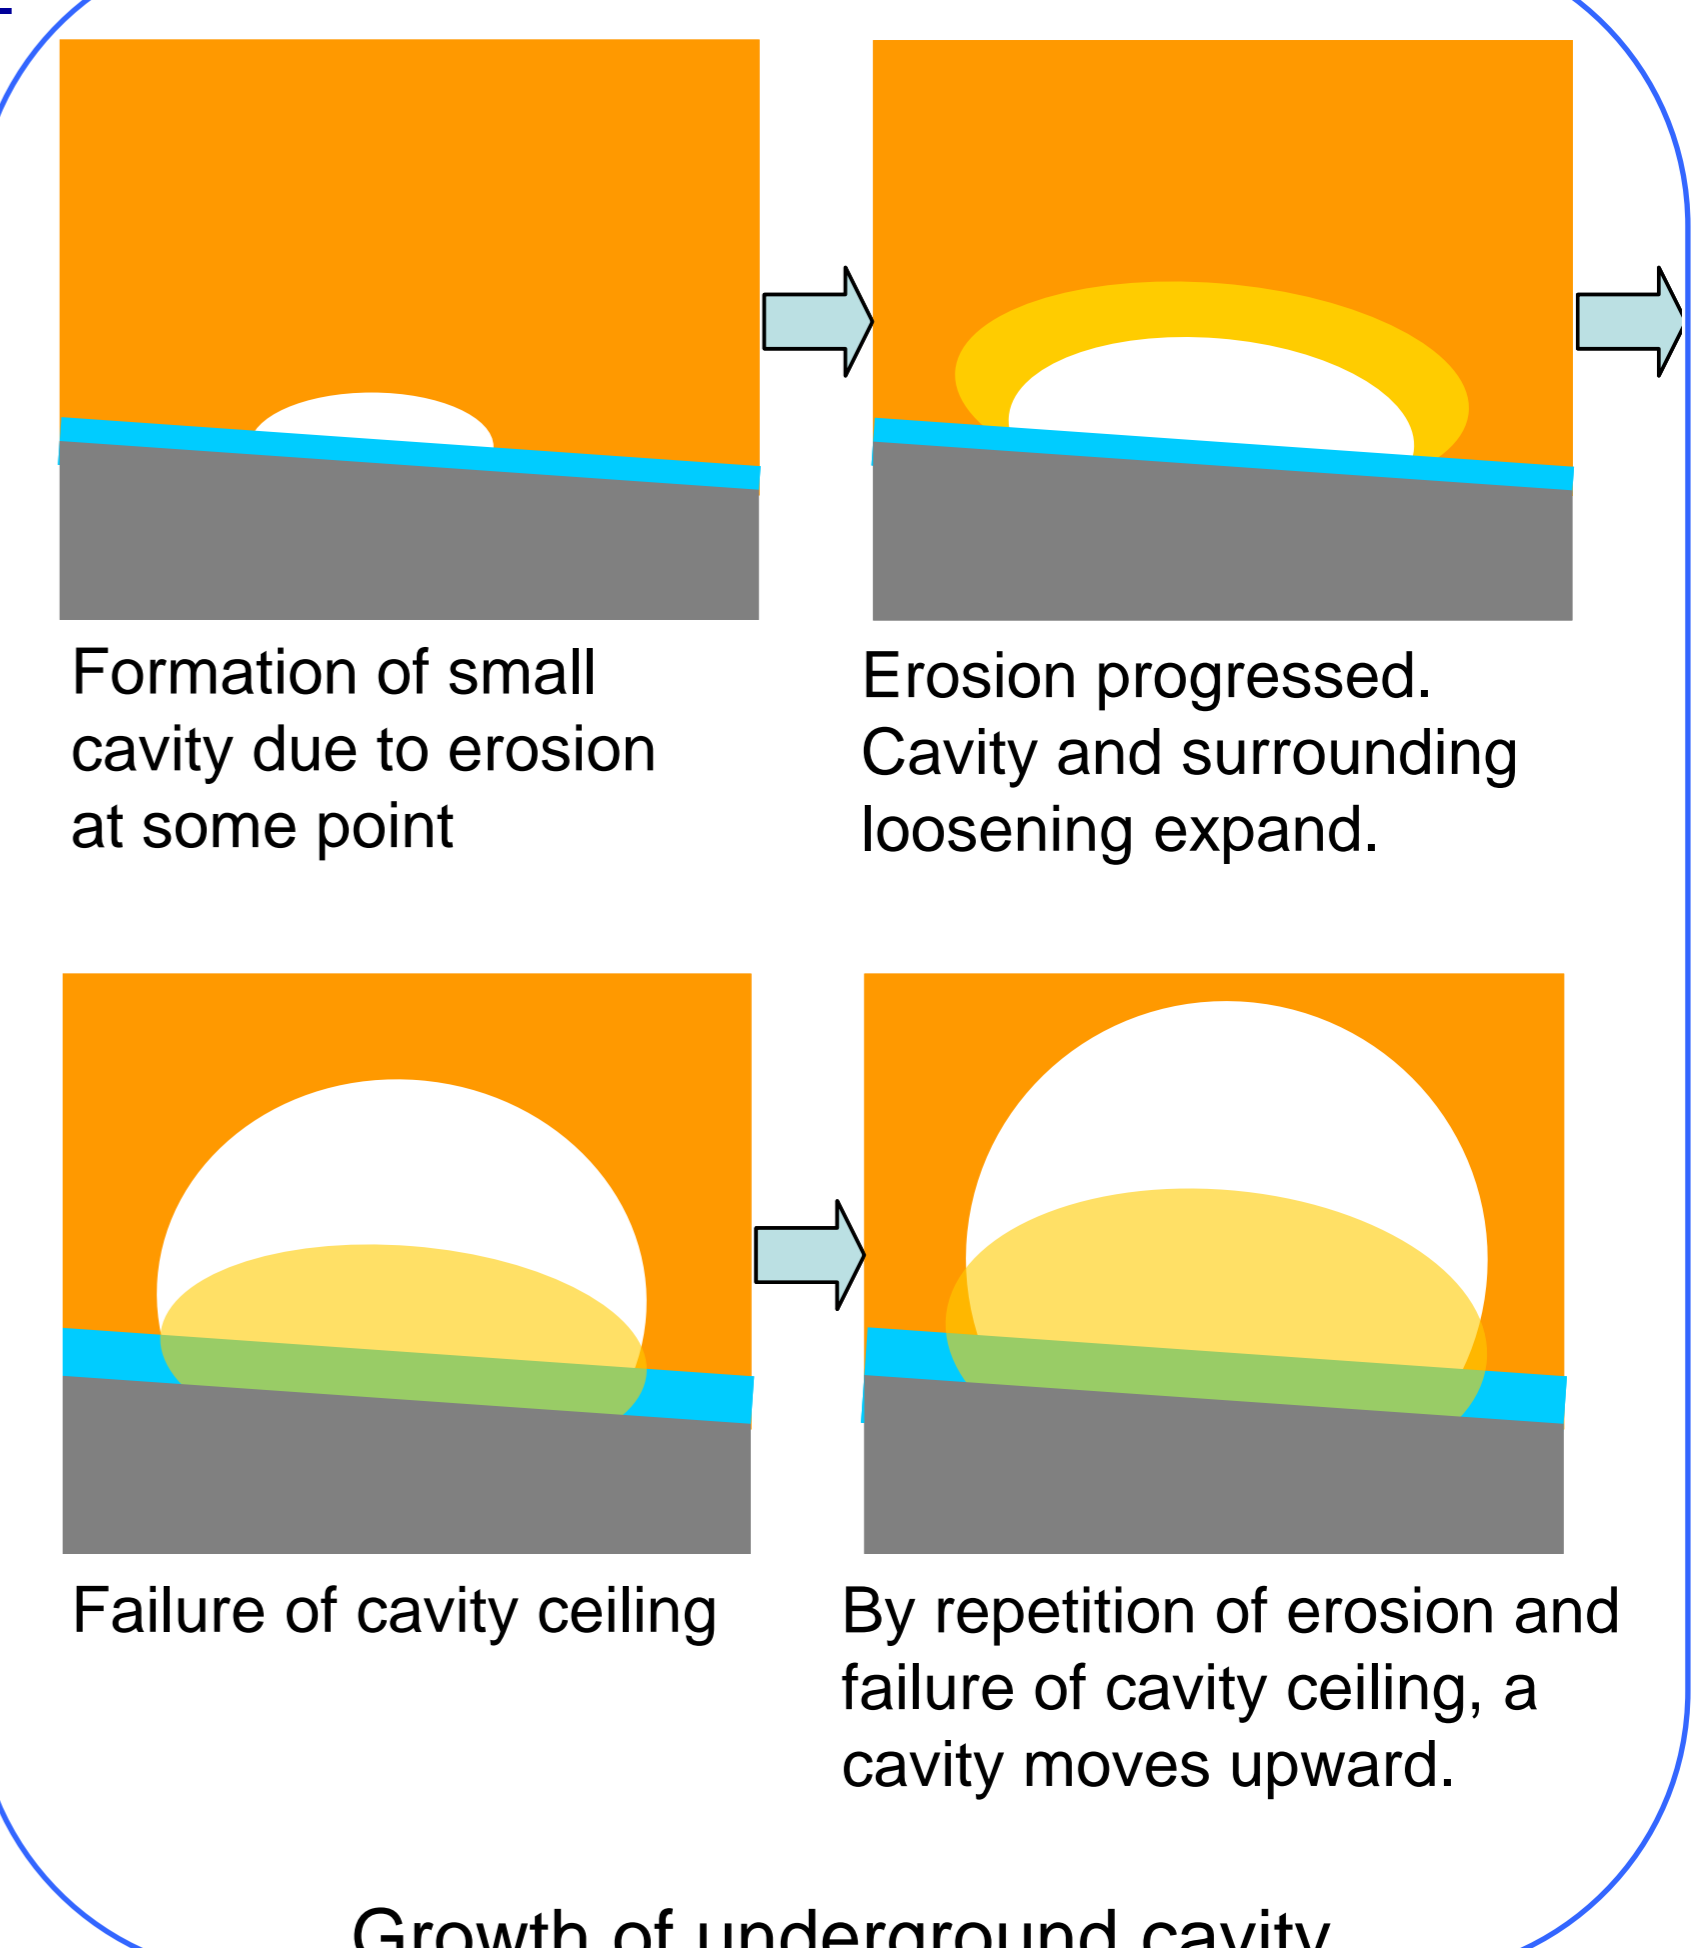
Growth of underground cavity
